EVALUATION OF THE DAMAGE TO THE BORAX CORPORATE HEADQUARTERS BUILDING AS A RESULT OF THE NORTHRIDGE EARTHQUAKE

Jerome F. Hajjar
DEPARTMENT OF CIVIL ENGINEERING
UNIVERSITY OF MINNESOTA
MINNEAPOLIS, MINNESOTA

SUMMARY

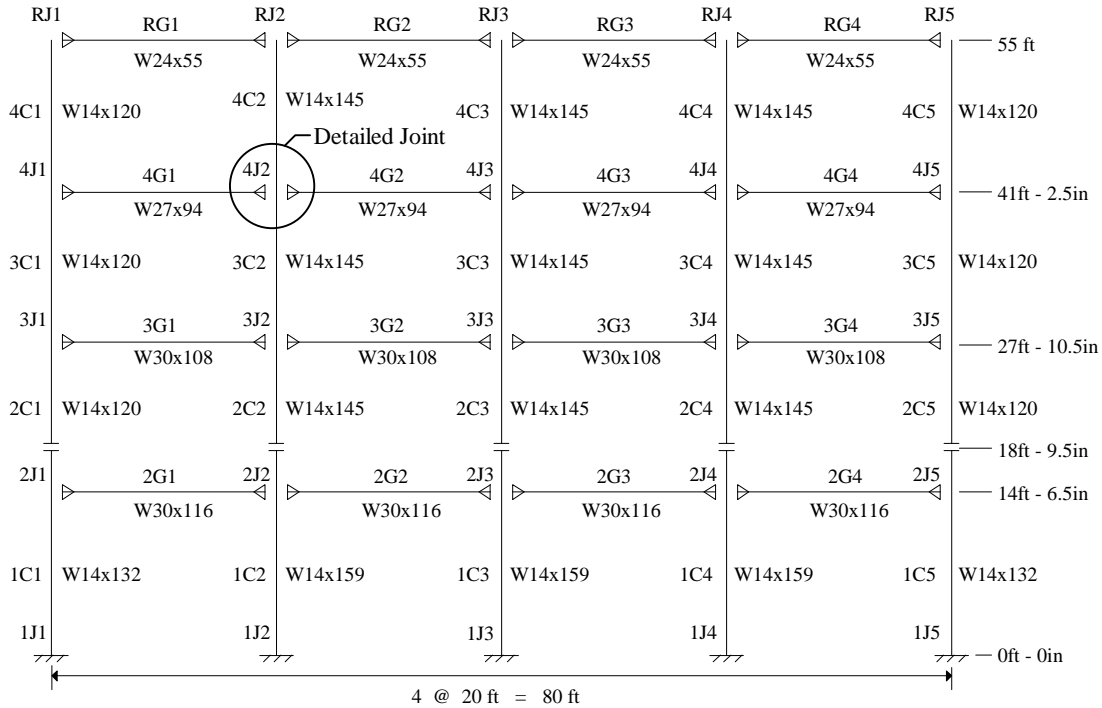
FIGURE 8-1: NORTH-SOUTH MOMENT FRAME ELEVATION

Due to the preponderance of connection failures in the two north-south frames of the structure (see Section 4), the 2D analyses focus on the north-south moment frame on the west side of the structure. As discussed in Section 3, this frame consists of four stories and four bays, with all columns having a nominal yield strength of 50 ksi, and all girders having a nominal yield strength of 36 ksi. **Figure 8-1** illustrates an elevation of the frame showing the joint and element notation that will be referenced below. The circled joint indicates a connection that was damaged in the Northridge earthquake (see **Figure 4-11**). This connection exhibited a crack across the entire column flange thickness originating at the full penetration weld connecting the bottom flange of the girder to the column flange (see **Figures 4-5** and **4-6**). This joint is examined in more detail in Section 9, as it serves as a representative connection in the frame.

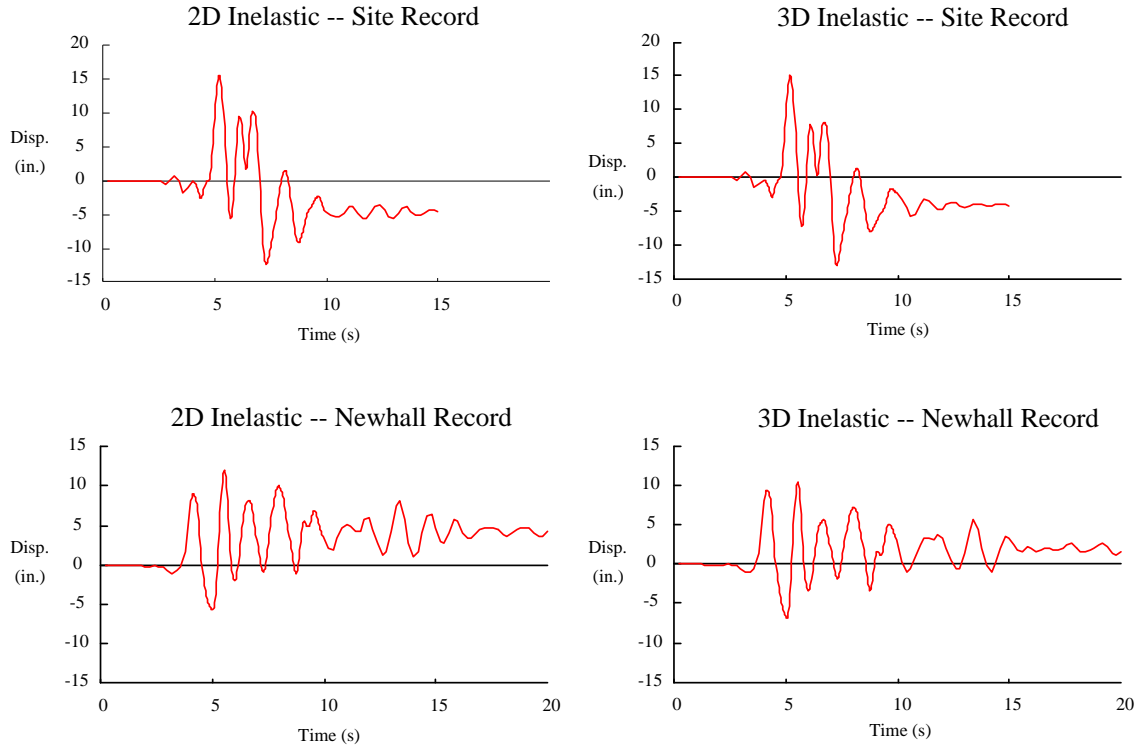
FIGURE 9-6: INELASTIC ROOF DISPLACEMENT VS. TIME

The 2D and 3D analyses produce similar displacement versus time curves for both the Site record and the Newhall record, both in magnitude and pattern (similar close correlation is seen in the time histories of the forces of the two models). This indicates that the 2D analysis reasonably simulates the total behavior of the 3D model, even though the distribution of displacements and ductilities throughout the height of the structure is ultimately somewhat different in the two models. The Site analyses show large excursions in the north direction, but both models damp out with residual displacements in the south direction. This points out that it is not necessarily the magnitude of displacements, but the pattern of yielding that determines residual displacements. Also, Lawson et al. (1994) demonstrated that very strong ground motions may result in no residual displacement in a steel frame structure, while considerably weaker accelerations result in large residual displacements. **Table 9-5** summarizes the residual displacements for the four inelastic dynamic analyses.

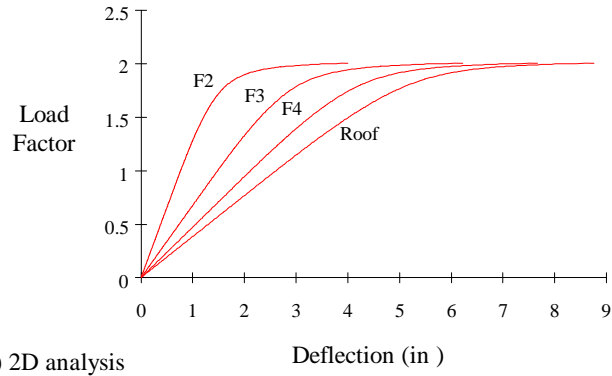
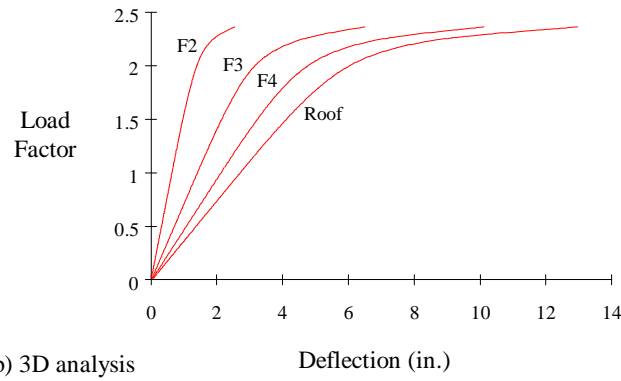
FIGURE 9-7: STATIC LOAD VS. INELASTIC STORY DISPLACEMENTS

<i>Story</i>	<i>2D Static Pushover</i>	<i>2D Dynamic (Site)</i>	<i>2D Dynamic (Newhall)</i>	<i>3D Static Pushover</i>	<i>3D Dynamic (Site)</i>	<i>3D Dynamic (Newhall)</i>
1	4.05	7.28	3.85	2.55	4.26	2.52
2	2.24	3.95	3.28	3.94	4.69	3.11
3	1.49	2.38	2.62	3.62	3.62	2.95
4	1.36	1.57	1.74	2.83	2.31	2.16

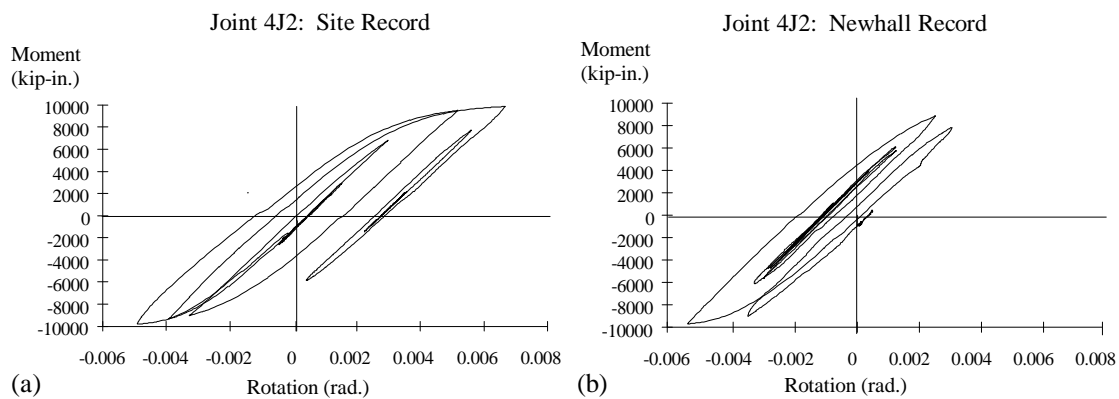
FIGURE 9-9: MOMENT-ROTATION CURVES FOR JOINT 4J2

Figure 9-9 illustrates the moment-rotation curves for this joint, generated from the 3D transient dynamic analyses of the structure. These plots are representative of the moment-rotation exhibited at many of the frame's joints in these analyses. As mentioned in Section 4, many researchers have suggested that two strong pulses may have induced the connection failures. These moment-rotation curves indicate, for both ground motions, two substantial changes in member rotation (e.g., for the Site record, a maximum rotation of 4 mrad is obtained after a first significant plastic excursion, followed by a more substantial excursion on the order of 6 mrad). Note that the rotations exhibited in this member (and in most of the members of this structure) are well below the level of 20 mrad or more that should be required to cause significant damage to this connection detail.
