Recommended Improvements to the Southwest Corridor Path Intersections

Transportation Capstone Class of 2009 Advisors: Peter Furth & Dan Dulaski

January-February 2009

Attention:	Mr. Jeffrey Ferris
Cc:	Professor Daniel Dulaski and Professor Peter Furth
	Northeastern University
Subject:	Report on Recommended Improvements for Bicycle Path Intersections
	Southwest Corridor Park
	Boston, Massachusetts

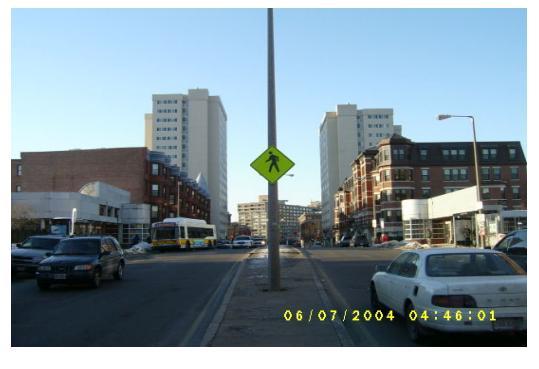
• There are currently three signs on Mass. Ave. to warn motorists of the crossing. However, they are attached to existing lampposts instead of being in an advanced position to warn cars. The one sign that is in an advanced position is too far away and about 10 feet off the ground much too high for a car to see. (see picture)

Pedestrian Warning Sign

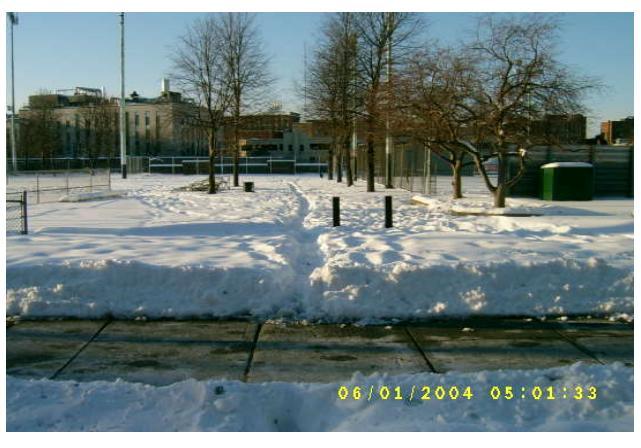
• Two bollards at the inbound entrance to Columbus Park make for a difficult entrance into the park.

WM E Carter Playground Entrance on SWCP

- Remove both bollards at park entrance and replace one of them in the middle of the bike path.
- Continue backstop from baseball field along path to playground and

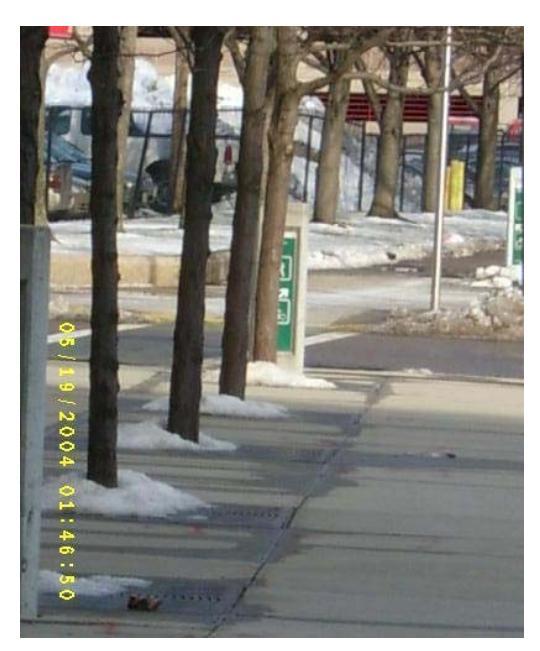
Southwest Corridor Heading Inbound-Poor Visibility

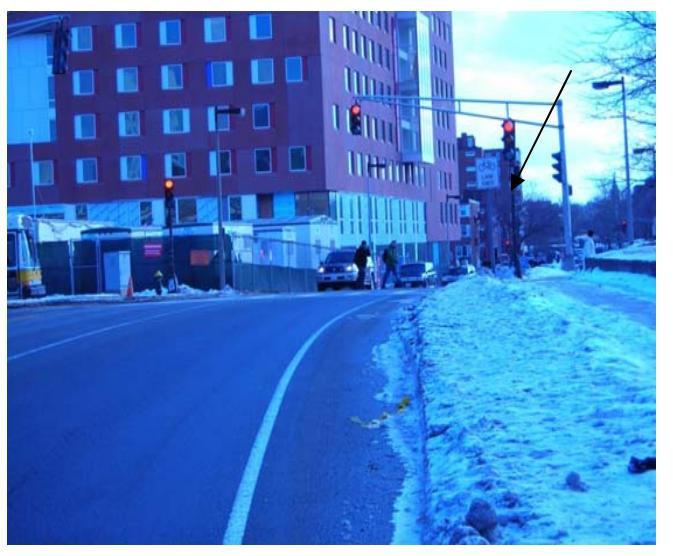
North-Side Leg Looking South

- Intersection Geometry
 - The crossing at Ruggles Street has some sightline issues. The amount of traffic that now uses Ruggles Street warrants some visibility improvements for motorists. The crossing on Ruggles Street lies on a horizontal and vertical curve at the same time as shown in the picture below. The actual crosswalk itself is not visible to oncoming traffic.
- Ineffective Signage for Vehicles
 - There are not any signs to warn cars of a pedestrian and cycle crossing ahead.
- Lack of Pavement Markings
 - There is no stop line on the Southside leg of the crossing.
- Lack of Pedestrian Clearance Time
 - Ruggles Street is 50 feet wide and there is only 10 seconds of pedestrian clearance time.

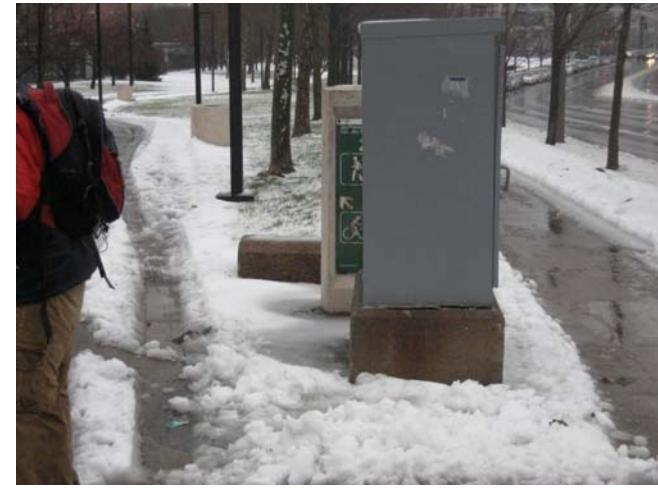
- Inbound directional bollard blocked by signal control box.
- Lack of signage indicating bicycle path crossing.
- Pavement/Path Markings
 - Stop bar is too close to the crosswalk resulting in vehicles blocking bicycles.
 - Crosswalk is in good condition and of acceptable width.

Inbound—Blocked Directional Bollard at Tremont Street

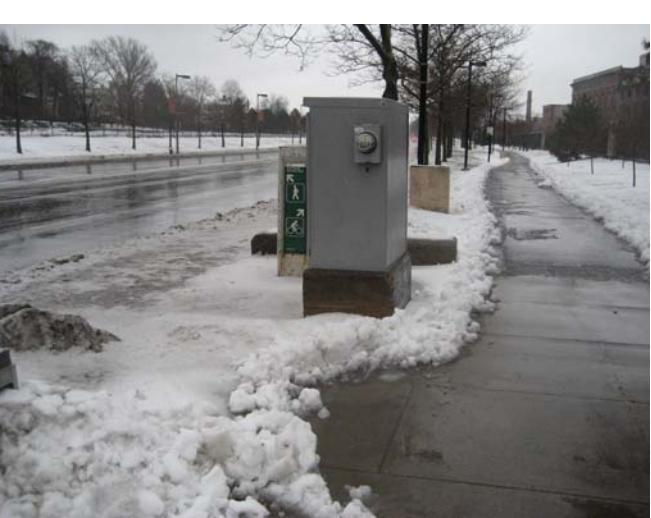
Outbound— Blocked Directional **Bollard at New Cedar Street**

- Move bollard in front of control box.
- Replace bicycle/pedestrian path crossing sign at vehicle approaches and put at appropriate height.
- Replace faded signs.
- Re-align 'Stop Here On Red' sign with stop line.
- Add signage on path warning of path merge.
- Promotional signage along vehicle approach alerting bicyclists of path and distances to destinations.
- Add NTOR sign on New Cedar Street so drivers will not stop in crosswalk.
- Crosswalk
 - Repaint ladder style crosswalk 10' wide.
 - Move crosswalk on Columbus back to allow for new ramp.

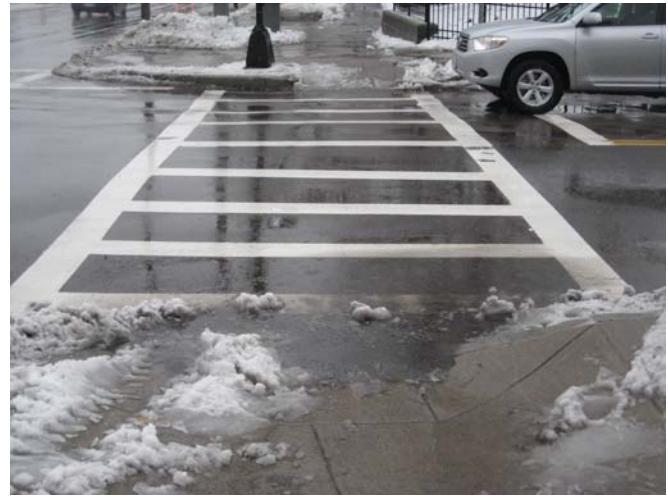
Narrow Ramps at Heath Street

- Remove cobble inlay and replace with asphalt to make for a smoother transition for bicycles and wheelchairs.
- Signal
 - Move signals to allow for widening of ramps.

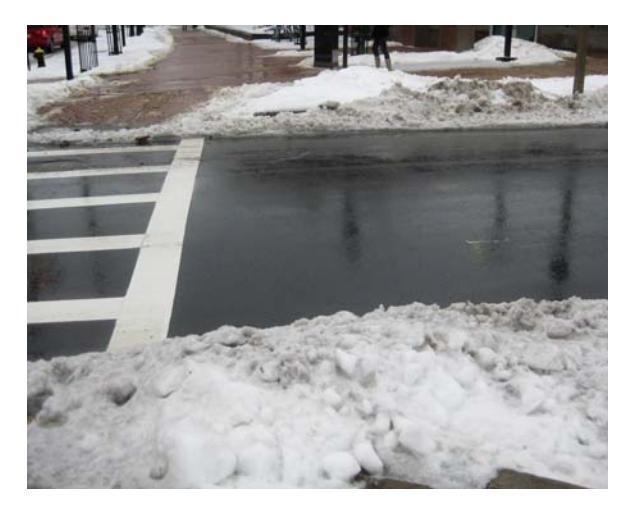
Missing Stop Line

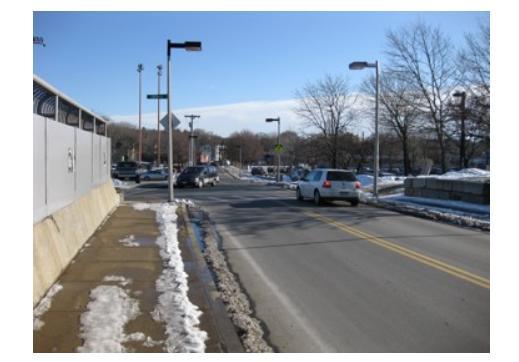
Steel Paneling Obstructing View

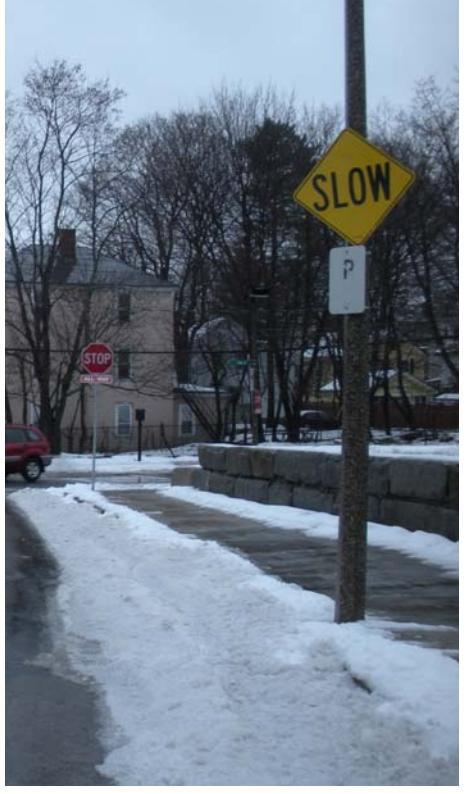
Minimal Path Crossing Signage

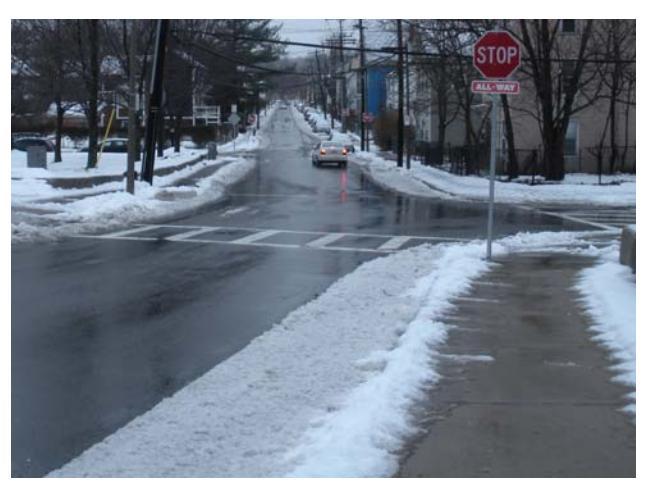
Missing Stop Line

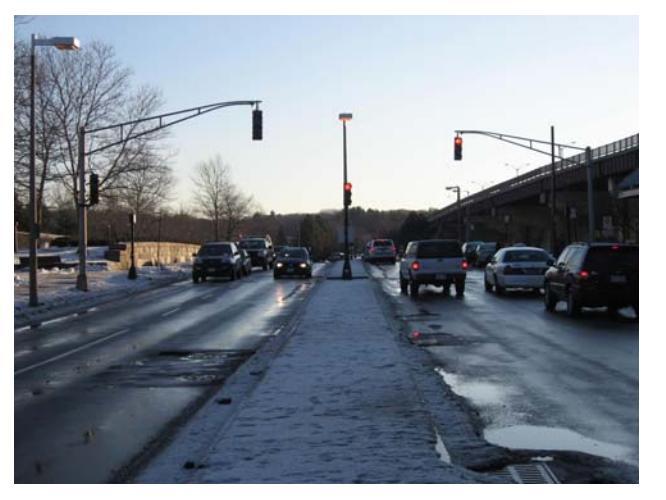
Lack of Path Warning

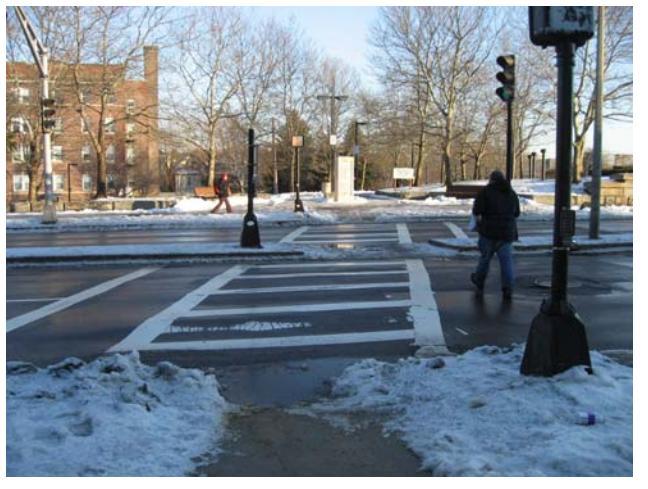
Misaligned Crosswalk/Narrow Ramps

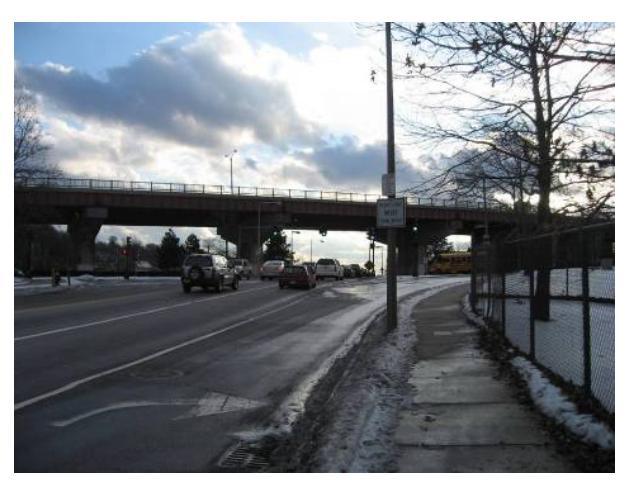
North Side Leg

- On the north leg of the intersection there is a right hand turning lane that has low traffic volumes.
