NSEL Report Series  
Report No. NSEL-017  
August 2009

# Behavior of Bolted Steel Slip-critical Connections with Fillers

**Daniel J. Borello**  
**Mark D. Denavit**  
**Jerome F. Hajjar**

Department of Civil and Environmental Engineering  
University of Illinois at Urbana-Champaign

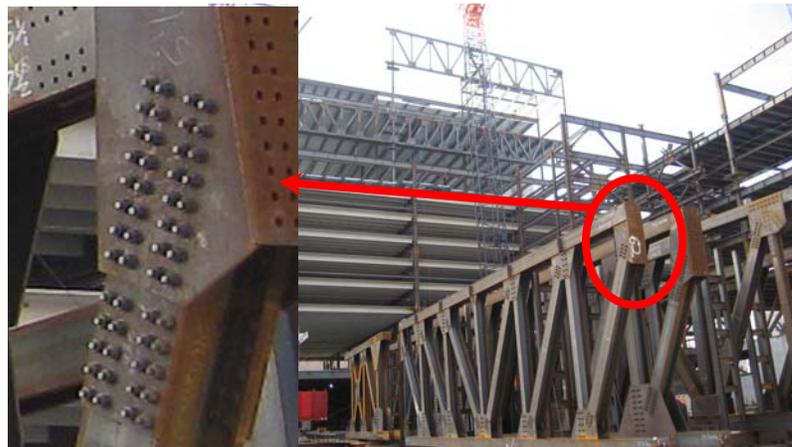
**Figure 1 – Example of filler plate connection in steel truss (from W&W Steel)**

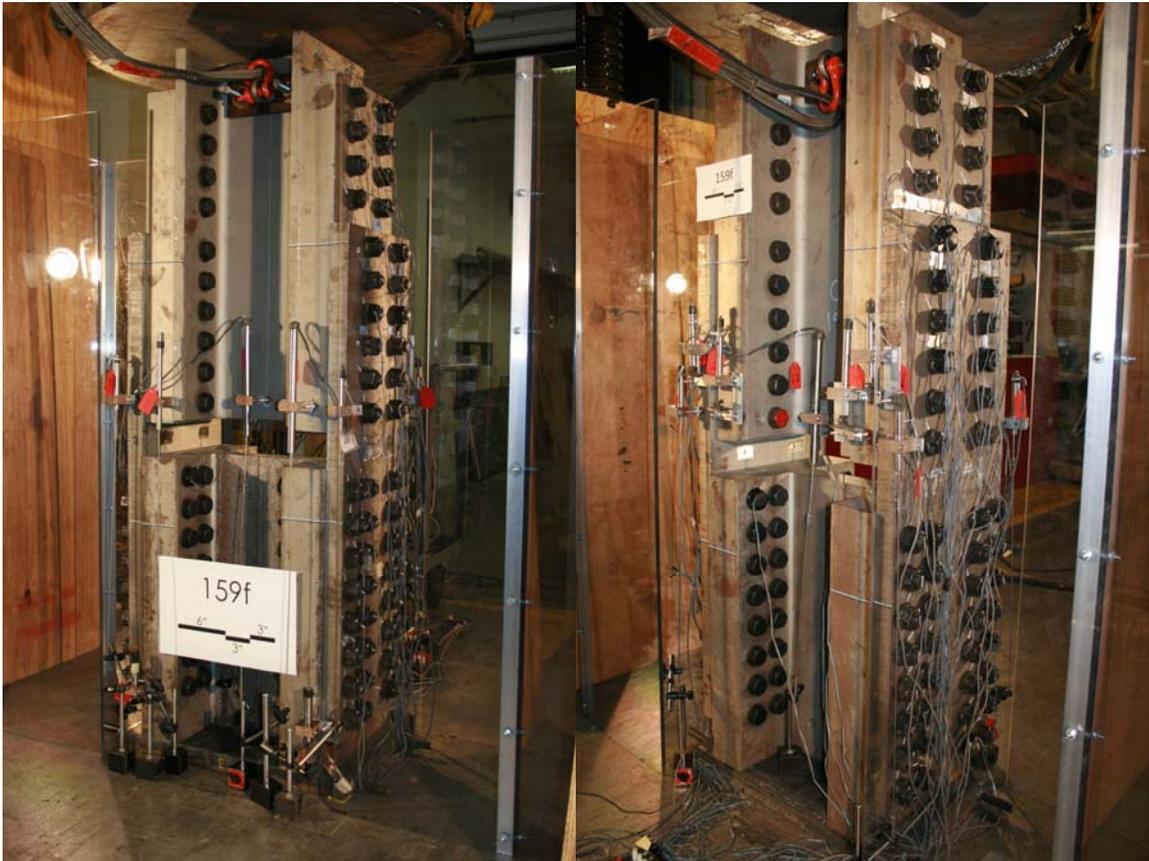
**Figure 5 – Typical UIUC test specimen**

The bottom column was connected to the splice plate with sixty-four 9 in. bolts. The top column was connected to the splice plate with twenty-four 9 in. bolts, with as many as sixteen additional 7 in. development bolts. The top columns were assembled in a reverse bearing condition to provide the opportunity for as much slip as possible within the bolt holes. Specifically, the specimens were assembled such that the bolts were placed in bearing on the bottom edge of the bolt hole on the top column, the bottom edge of the bolt hole on the filler plate, and the top edge of the bolt hole on the splice plate. The bottom columns were assembled such that the bolts were placed in bearing on the bottom edge of the bolt hole on the bottom column and the top edge of the bolt hole of the splice plate so as to minimize the possibility of slip of the splice plate relative to the bottom column.

The specimens were tested in Talbot Laboratory at the University of Illinois at Urbana-Champaign. The 3,000,000 lb. Southwark-Emery Tension/Compression testing machine (Figure 7) was used to load each specimen in compression. The top loading platen contained a spherical head which was locked into place prior to testing (Figure 8) to inhibit specimen rotation. This was done for several reasons, including to mirror the boundary condition underneath the bottom column, and because a locked condition was deemed more likely to reflect the boundary condition in the field for the column stub. For all but the first specimen tested (730-std), a steel plate was placed between the floor of the testing machine and the specimen so as to protect the steel floor (Figure 5). Similarly, for all specimens, a steel plate was placed between the top of the specimen and the spherical head (Figure 5).

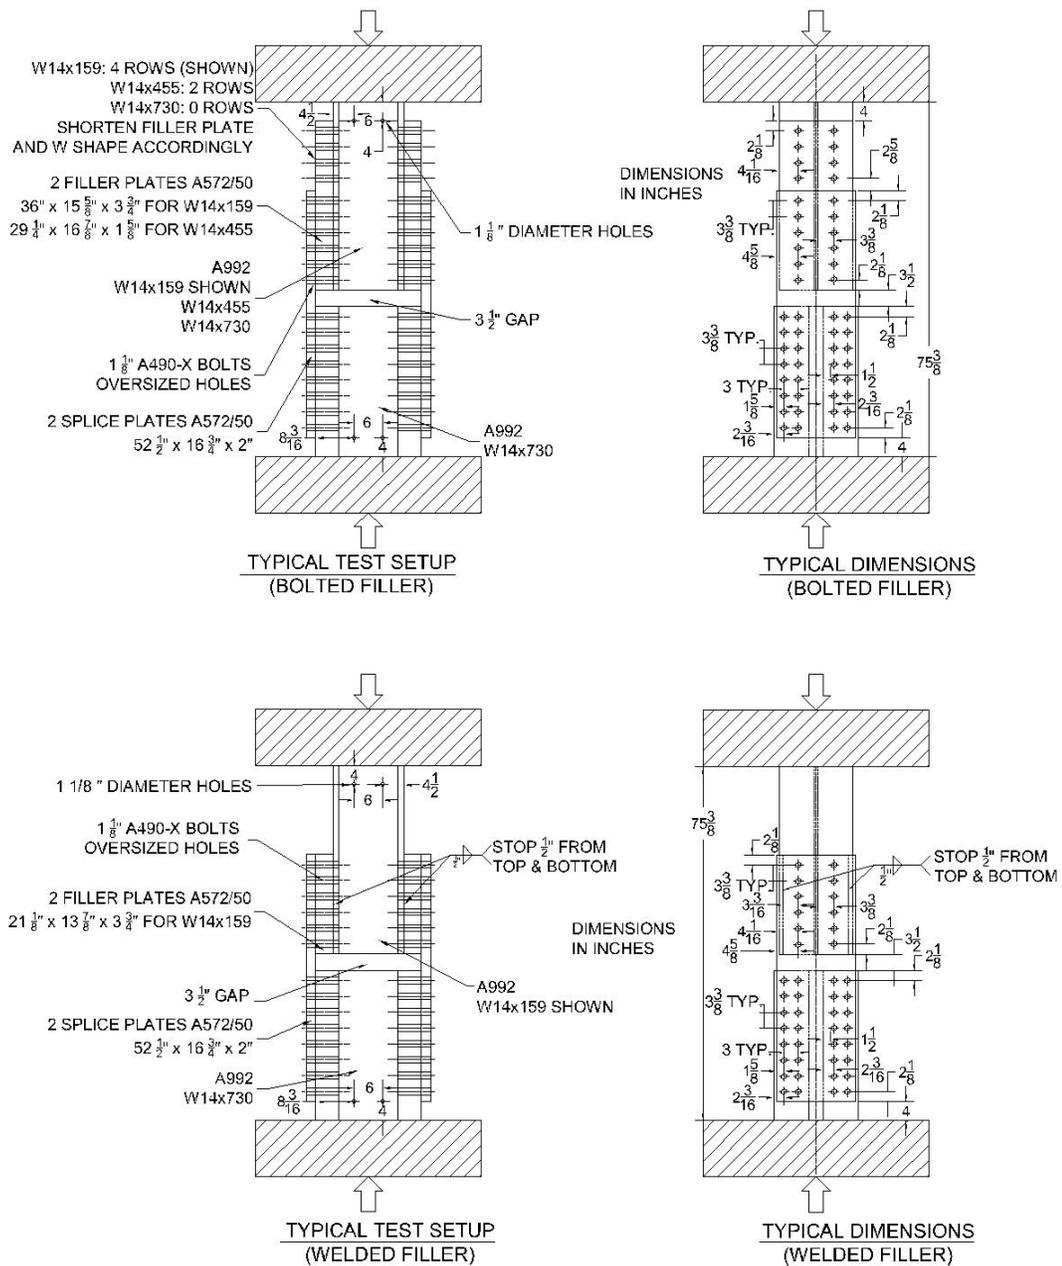
**Figure 6 – Typical UIUC test specimen configuration**

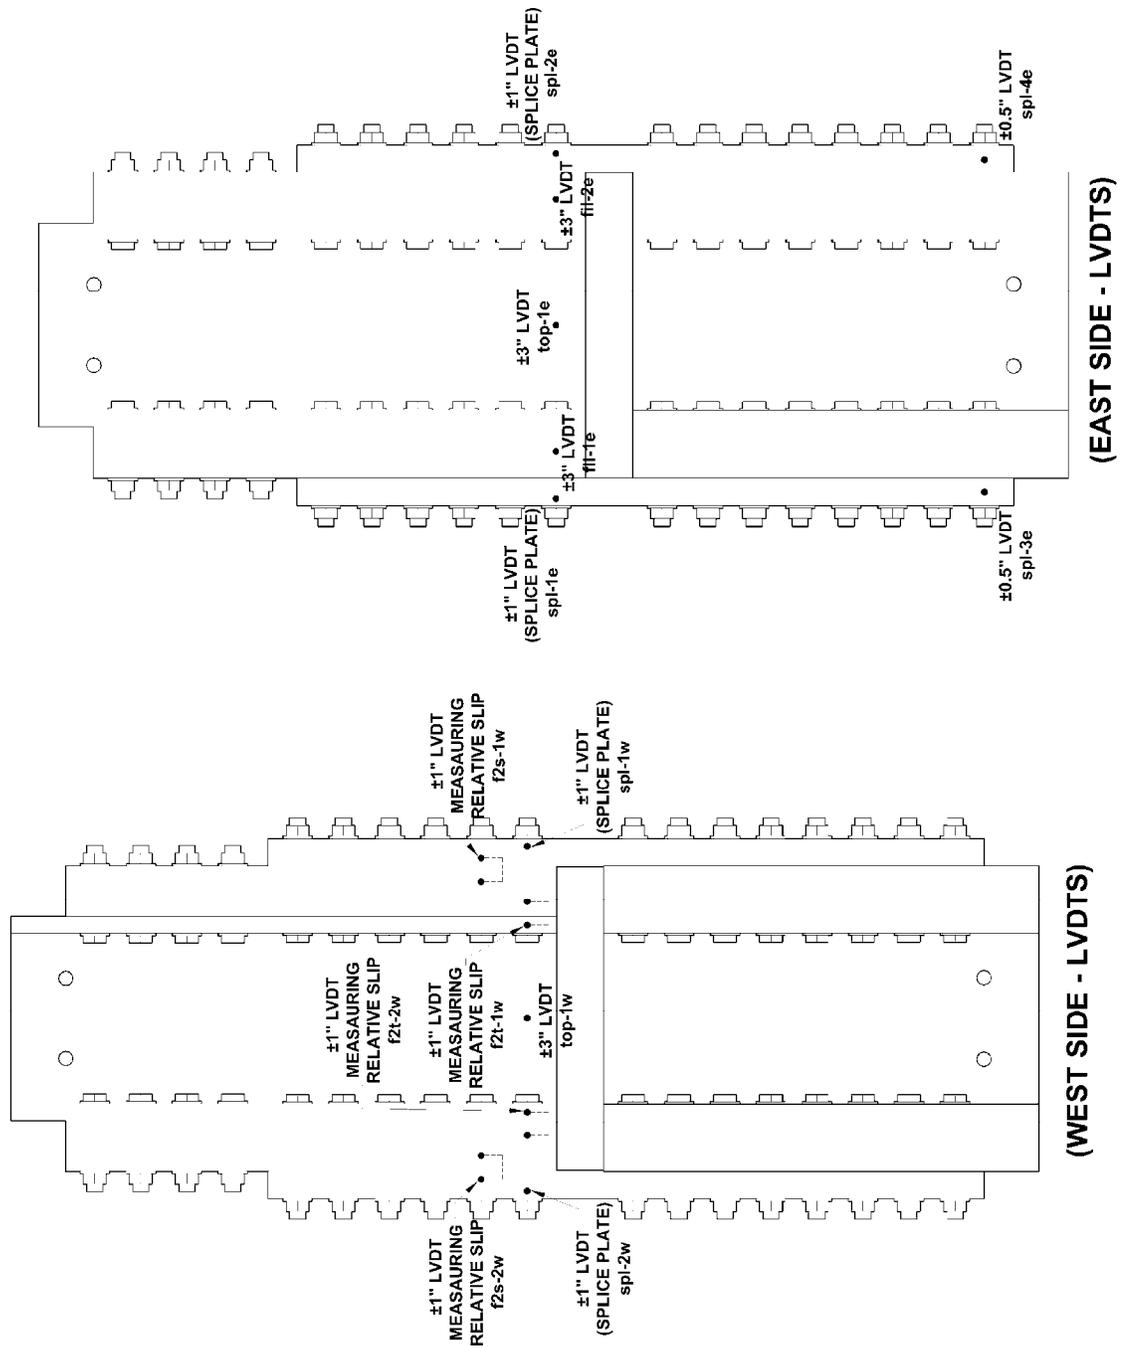
Figure 10 – LVDT Instrumentation Plan

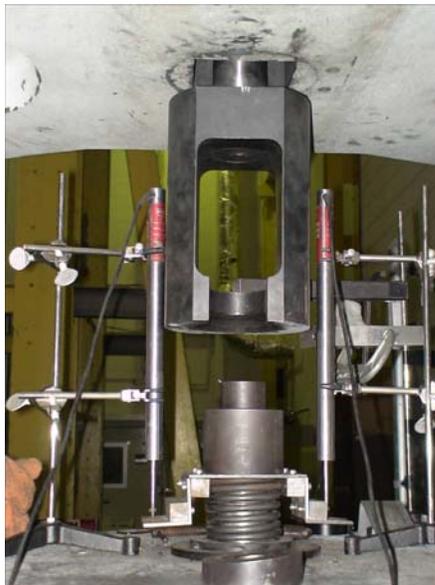
**Figure 12 – Bolt tension test apparatus [from (Rassati and Swanson, 2007)]**

Bolt tension tests on the TN bolts were conducted in accordance with ASTM standards (ASTM, 2006) using the testing apparatus shown in Figure 12. The failure surfaces were at approximately a 45 degree angle and through the threads (Figure 13). The relationship between the tensile load and bolt elongation from these tests is shown in Figure 14. The average tensile strength was 122 and 128 kips with a standard deviation of 0.78 and 1.9 kips for the 7 in. and 9 in. TN bolts, respectively. The tensile strength was calculated based on the stressed area (Kulak et al., 2001) and determined to be 160 ksi and 168 ksi for the 7 in. and 9 in. TN bolts, respectively.

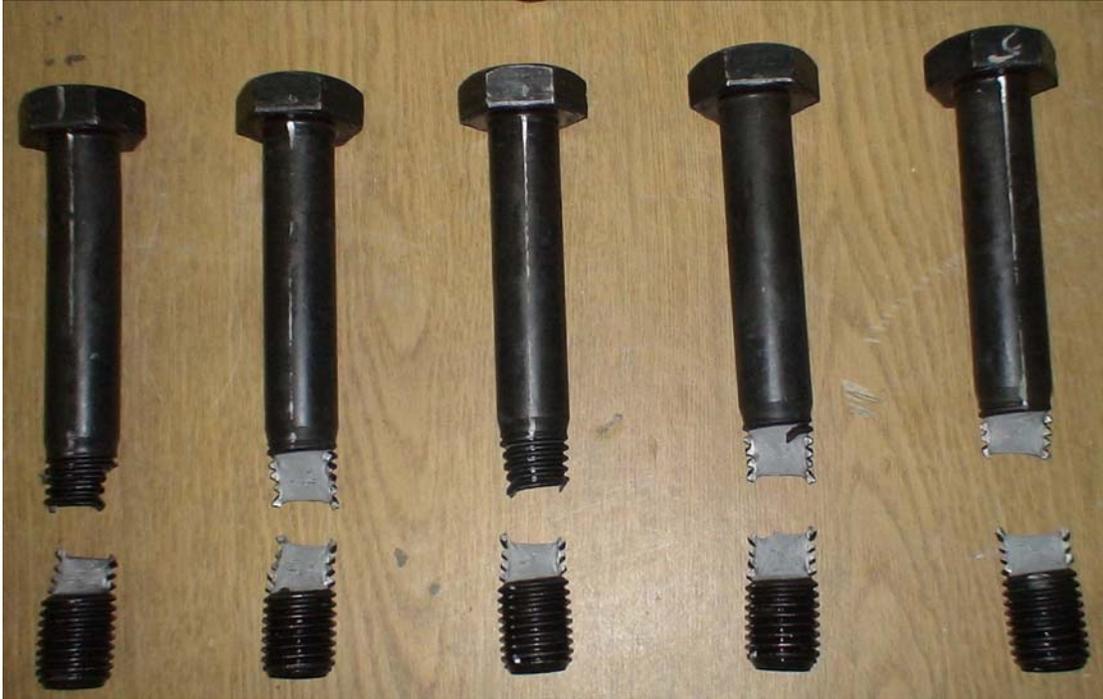
**Figure 13 – Failed TN bolts due to tension [from (Rassati and Swanson, 2007)]**

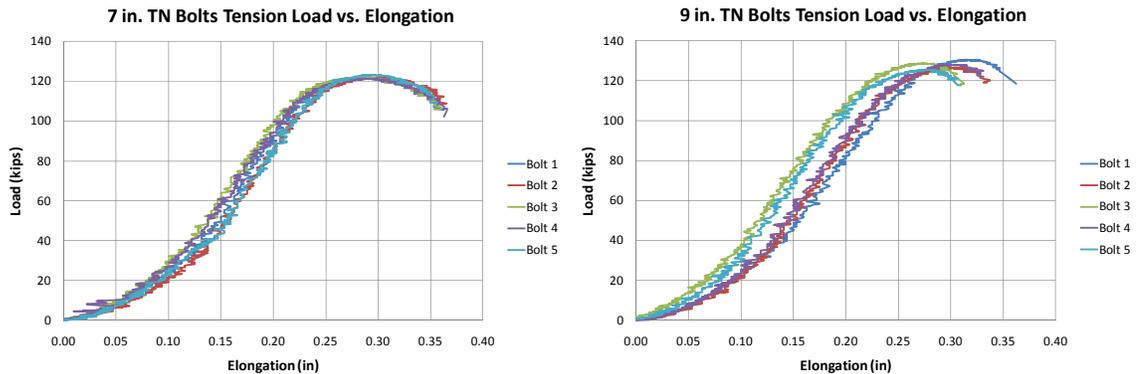
**Figure 14 – TN bolts tension test results**

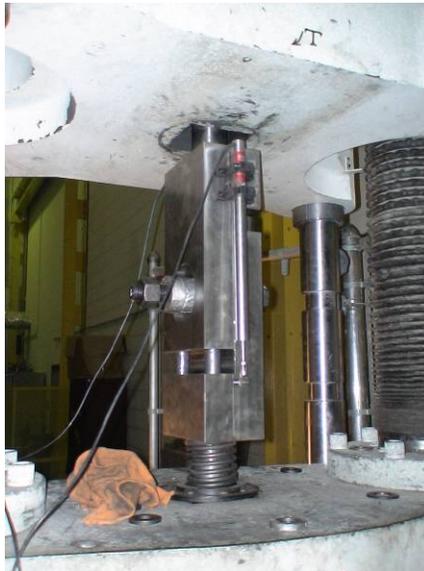
Figure 15 – Bolt shear test apparatus [from (Rassati and Swanson, 2007)]

Bolt shear tests on the TN bolts were conducted in accordance with ASTM standards (ASTM, 2006) using the testing apparatus shown in Figure 15. The failure surfaces were relatively flat and smooth as shown in Figure 16. The relationship between shear force and bolt deformation is shown in Figure 17. The initial stiffness of bolt 1 and bolt 2 was initially influenced by accidental resistance provided by the test apparatus; the peak load was still accurate. The average shear strength was 99 and 102 kips with a standard deviation of 0.89 and 0.535 for the 7 in. and 9 in. TN bolts, respectively. Based on the area of the bolt shank, the shear strength was determined to be 99 ksi and 102 ksi for the 7 in. and 9 in. TN bolts, respectively.

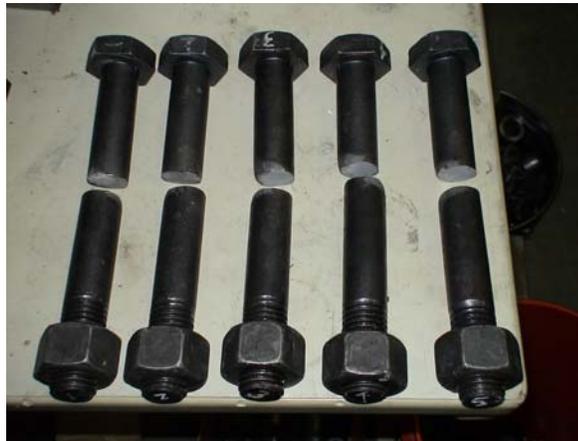
Figure 16 – Failed TN 9 in. bolts due to shear [from (Rassati and Swanson, 2007)]

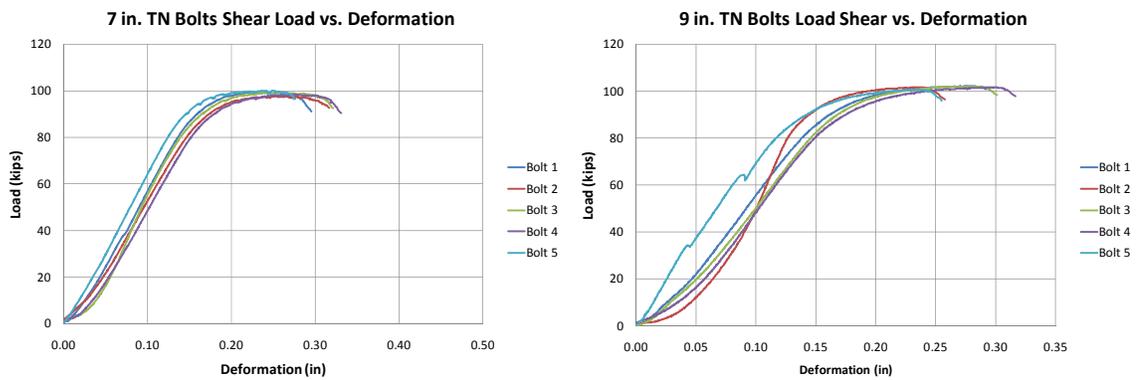
Figure 17 – TN bolt shear test results

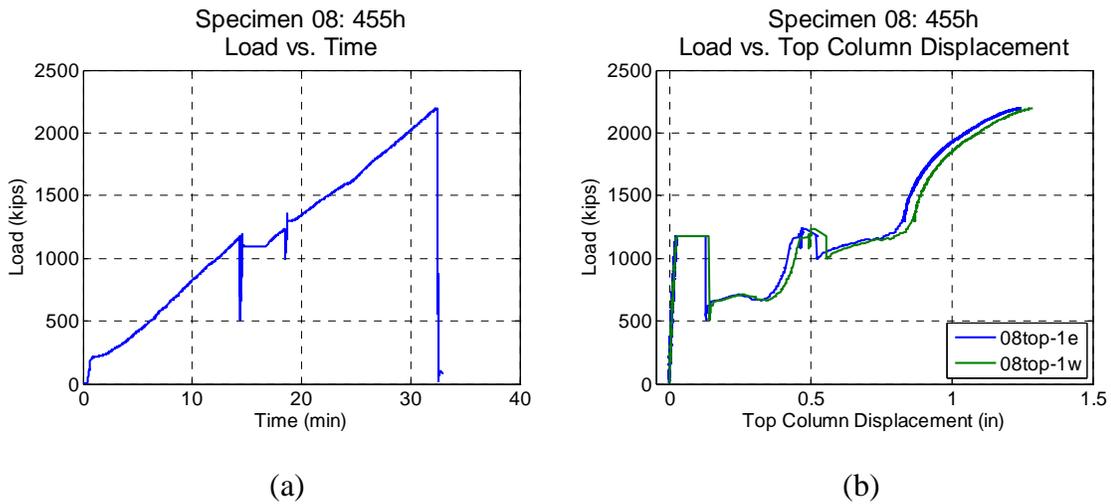
**Figure 24 – Typical specimen response: (a) load versus time; (b) load versus top column displacement**

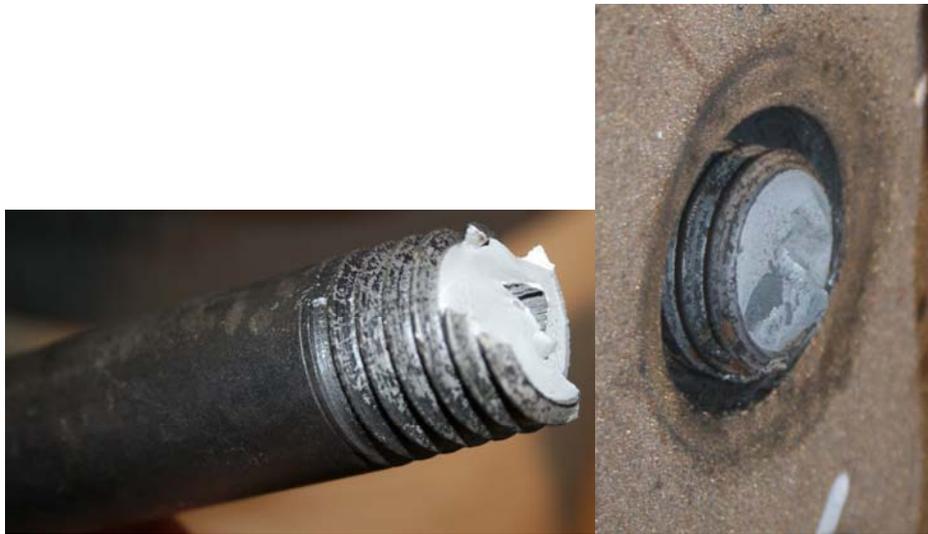
**Figure 25 – Premature bolt failure through threads**

After slip, prior to shear, several bolts prematurely failed (see Appendix B) through the threads at the face of the nut (Figure 25); no correlation was found with overall specimen performance and these premature bolt failures, as the shank of the bolt often stayed in the hole. For example, specimen 455n1 suffered from three premature bolt failures during slip, for all of which the shank remained in the bolt hole. Compared to specimen 455n2, in which no bolts failed prematurely, the shear strength of specimen 455n1 was only 2% lower instead of the 12.5% predicted reduction associated with the premature failure of three bolts.

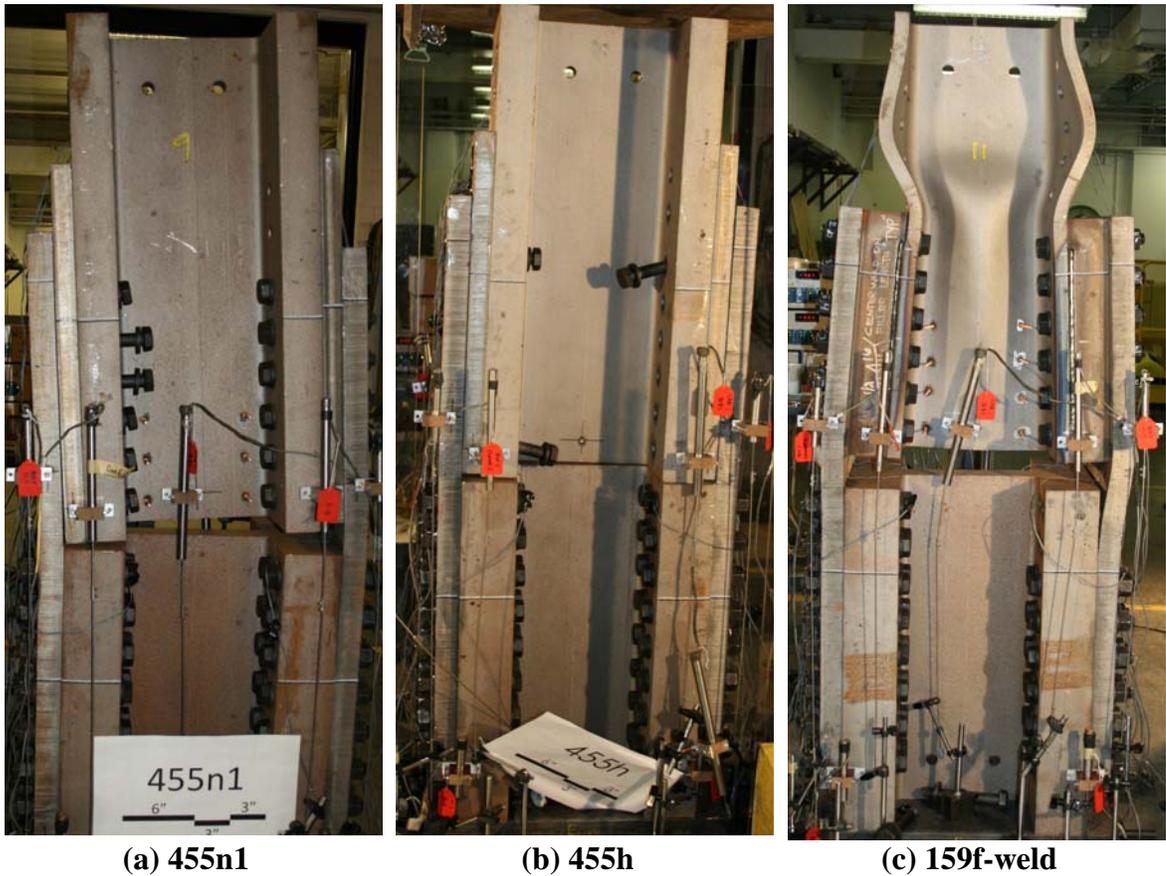
**Figure 27 – Specimens after shear**

At failure, all bolts on one side of the specimen were suddenly sheared into two pieces (Figure 27(a)). The bolts often exited the specimen with significant velocity. After one side failed, the load was removed from the specimen. If the load were to remain, the other side would also fail, as was the case in 455h (Figure 27(b)). Thirteen of the specimens reached shear failure; eleven failed on the south side, two failed on the north side. The more frequent failure on the south side could not be attributed to any specific measured loading bias and was thus thought to be statistically valid. The top column of specimen 159f-weld experienced detrimental local buckling after it yielded but prior to the shear strength of the connection (Figure 27(c)).

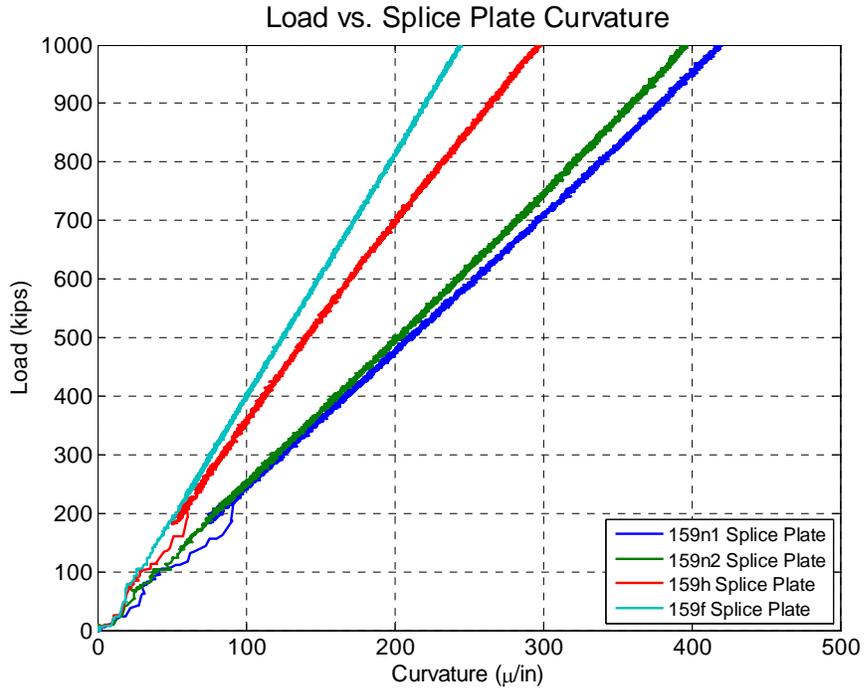
**Figure 29(a) – Curvature in splice plate at column cap vs. load for 159 specimens**

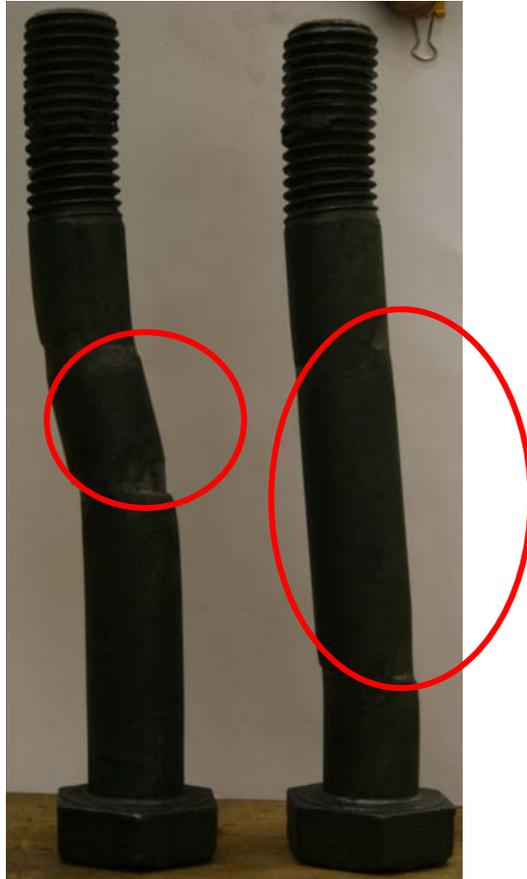
**Figure 32 – Intact bolts from 455n2 (left) and 159h(right)**

Even though specimen 455n2 had the lowest ultimate load, it had the largest bolt hole deformation on the each surface. Since the 455 specimens had the thinnest filler, the bolt was allowed to rotate more without restraint from the filler plate. This caused the bolt to bear on the plates directly at the edge, providing a smaller bearing surface for the bolt. This increased the stress on the plates and they subsequently suffered further deformation, possibly responsible for the softening behavior prior to shear failure. The bolts in the 159 specimens on the other hand were restrained from rotating due to the thick filler, allowing for a large bearing surface. Figure 32 shows bolts from 159h and 455n2 that were removed during disassembly. The highlighted regions are the part of the bolt within the filler plate. It is clearly seen that the 455n2 bolt had greater rotation inside the filler plate than the 159h bolt. If the filler plate were constructed of lower strength steel, the bearing deformation would have been larger, reducing the bolt rotation restraint

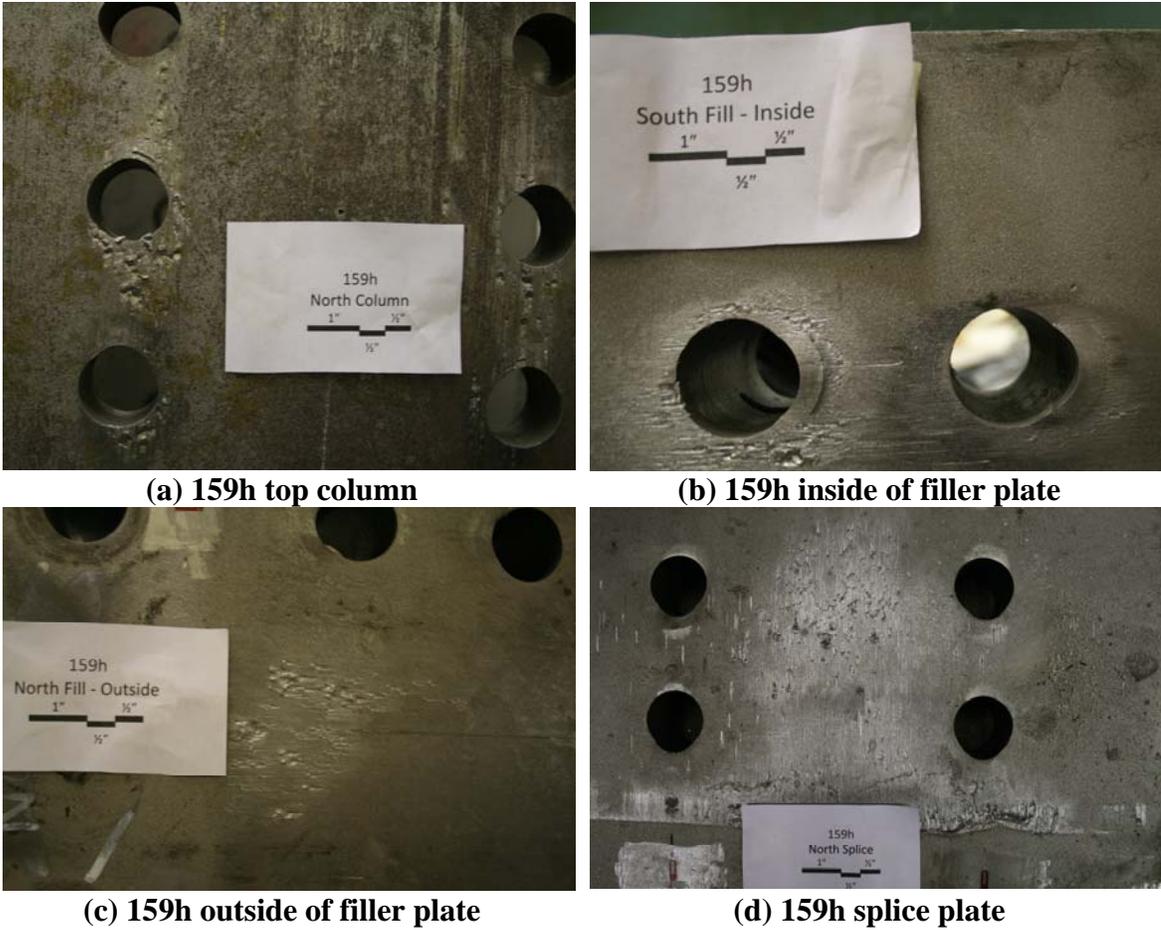
Specimen 159h had significant gouging around the bolt holes on the top column (Figure 33(a)) and inside face of the filler plate (Figure 33(b)). The outside face of the filler plate and inside face of the splice plate had gouging between the bolt holes (Figure 33(c) and (d)). There was significant gouging between the bottom of the filler plate and splice plate (Figure 33(d)), consistent with the additional frictional resistance mechanism analysis presented in Section 4.4. The effect of the gouging between the plates is a possible cause of the observed 34% increase in slip resistance. It is also likely that the gouging still provided resistance after the bolt pretension was relaxed, contributing to the shear strength of the connection, which was 19% higher than expected.

**Figure 33 – Specimen 159h faying surfaces**

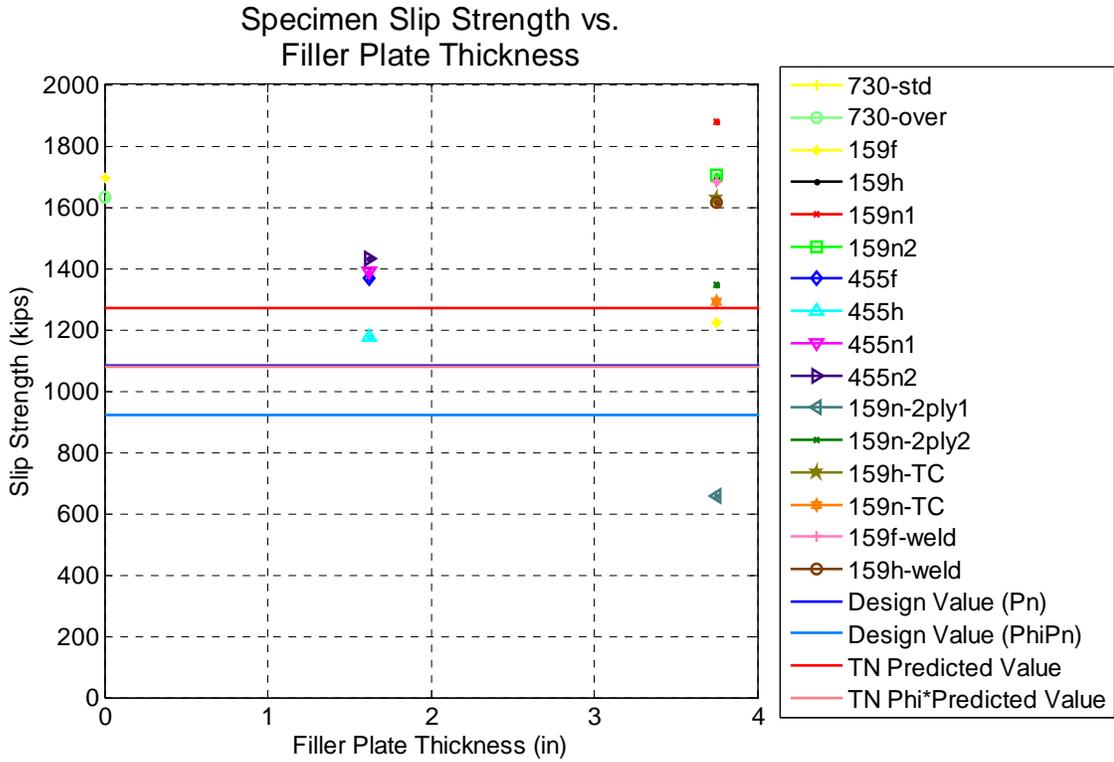
**Figure 36 – Slip strength vs. filler plate thickness**

From Table 10, Figure 36 and Figure 37, it may be seen that both specimens without a filler plate (specimens 730-std and 730-over) achieved greater slip strengths than their predicted values. Also, consistent with previous work demonstrating that there is no consistent relationship between hole oversize and slip resistance (Frank and Yura, 1981), only a slight difference was noted between the slip strengths of 730-std and 730-over.

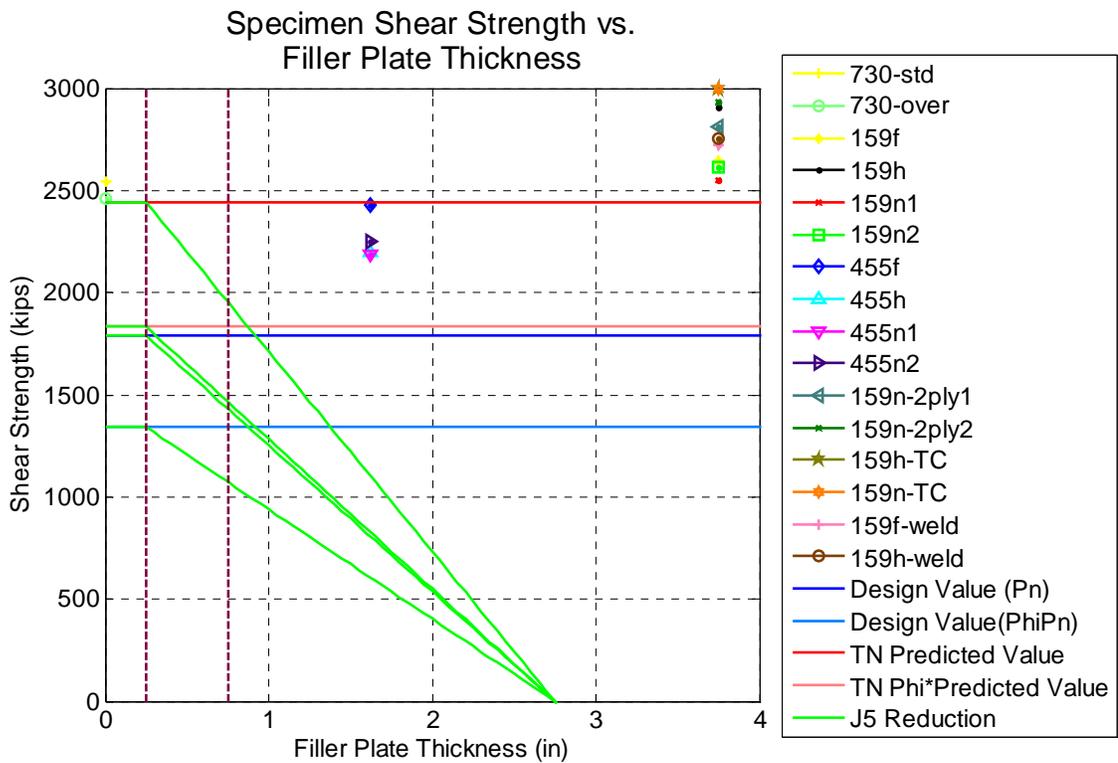
**Figure 41 – Shear strength vs. filler plate thickness**

The shear strength of specimens 159h-TC and 159n-TC exceeded the capacity of the testing machine. The shear strength of specimen 159f-weld was not achieved due to local buckling of the top column prior to shear failure, but after the predicted yield strength. For these three specimens, the lower bound of shear strength was plotted but was neglected for statistical calculations.

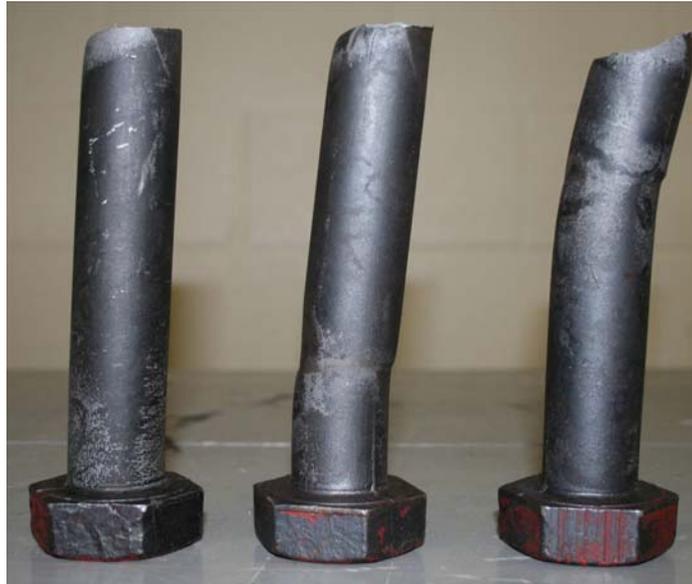
**Figure 46 – Specimen bolt deformation (730-over, 159n1, and 455n1)**

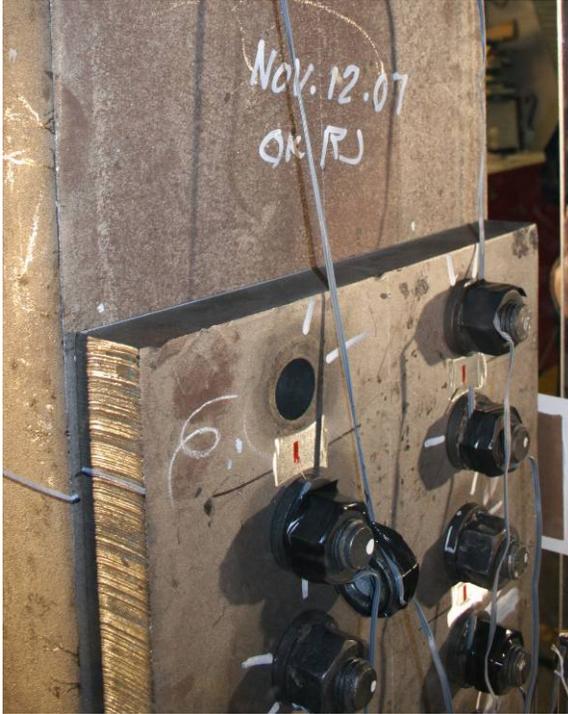
**Figure B.26 – 730-over: Early bolt failure (south side)**

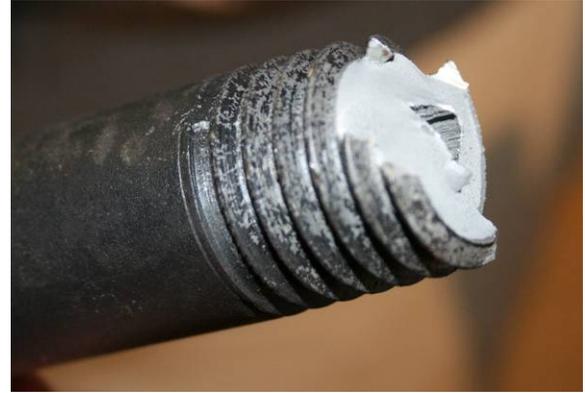
**Figure B.27 – 730-over: Early Bolt Failure**

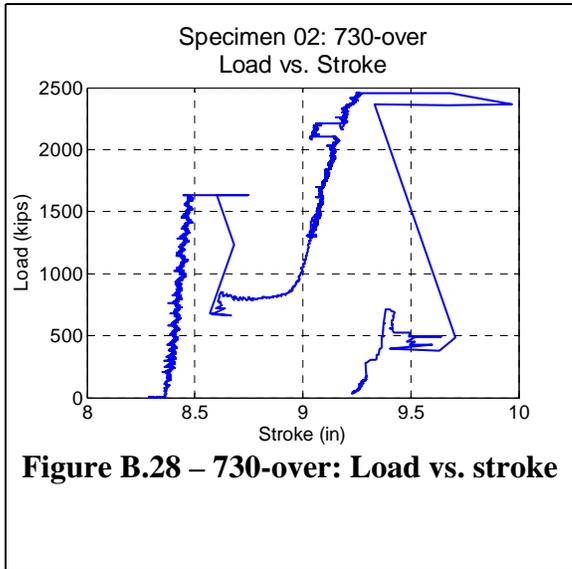
**Figure B.28 – 730-over: Load vs. stroke**

Specimen 730-over (Figure B.22 to Figure B.44) displaced approximately linearly with applied load (Figure B.28 and Figure B.30) until the observed slip load (1,634 kips). At the slip load, the relative displacement between the splice plates and the top column increased suddenly by approximately 0.57 inches over a period of approximately 20 seconds (Figure B.35) (as compared to 0.09 in. for a similar event for 730-std). This is most clearly seen in the relative LVDTs between the top column and splice plates (Figure B.33) and the movement of the top column (Figure B.30). The maximum expected clearance in the holes based on the assembly procedure and standard holes was  $2 \times (5/16 \text{ inches}) = 0.625 \text{ in.}$  During this dynamic event, the load dropped immediately to 665 kips and then increased to approximately 1,300 kips (reaching 1475 kips briefly first), where the load was held for observation of the specimen (Figure B.29). It is also likely that the bolts slipped into bearing during this slip event, as no appreciable change in stiffness occurred in the initial phases of loading after testing was resumed.

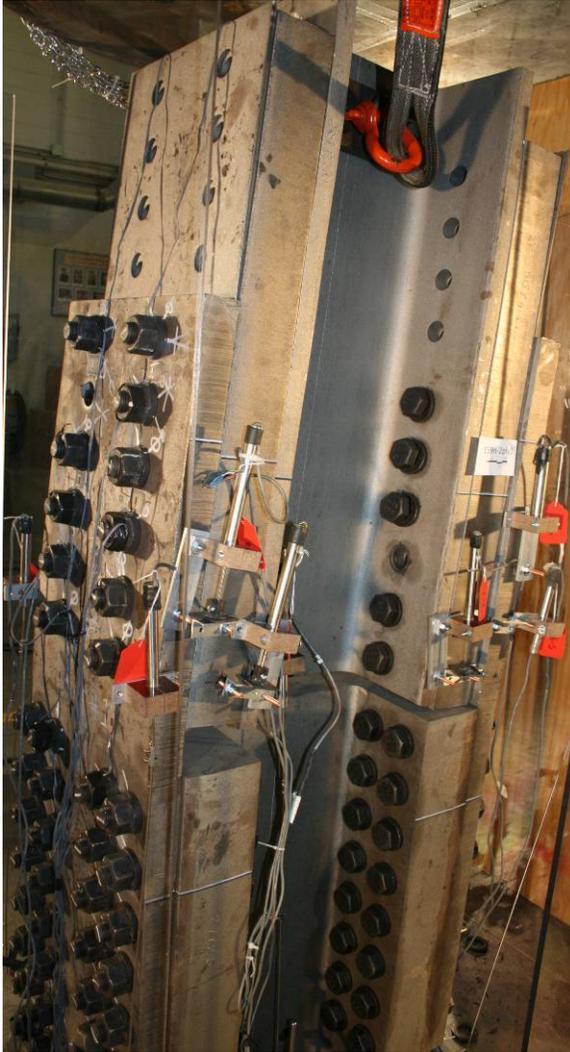
**Figure B.276 – 159n-2ply1: Initial single bolt failure (northwest corner)**

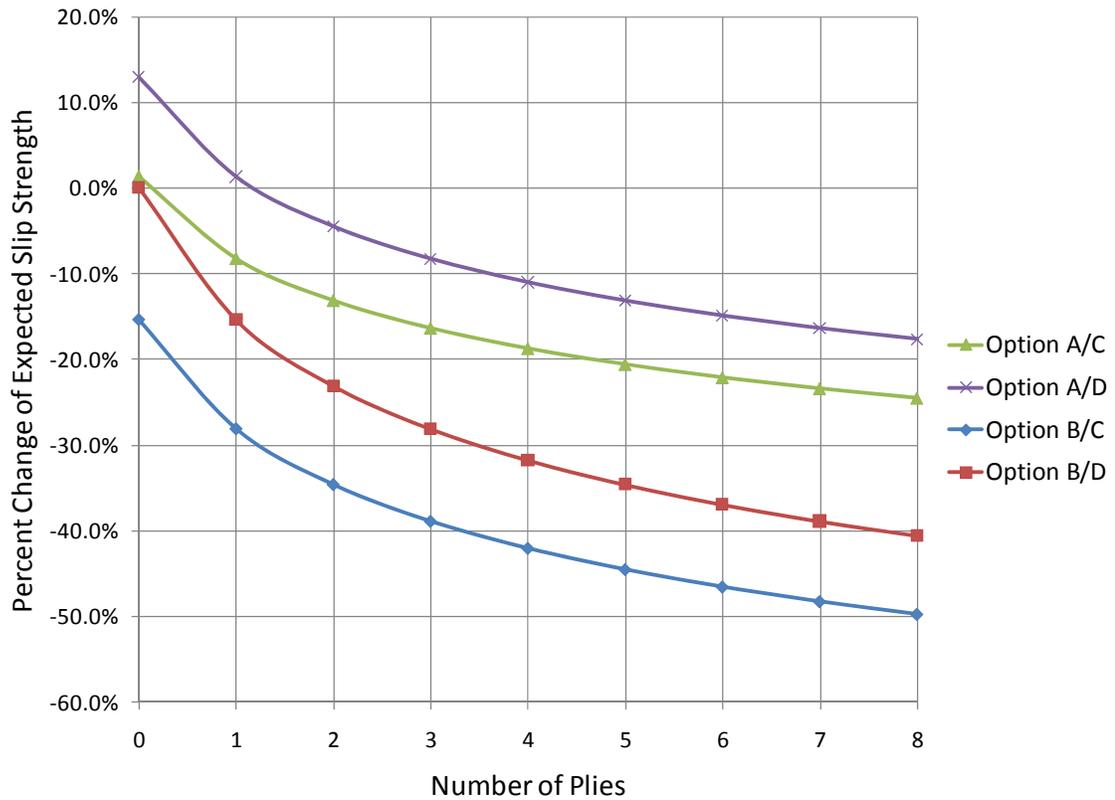
**Figure D.1 - Percent change of expected slip strength for connection with undeveloped fillers**

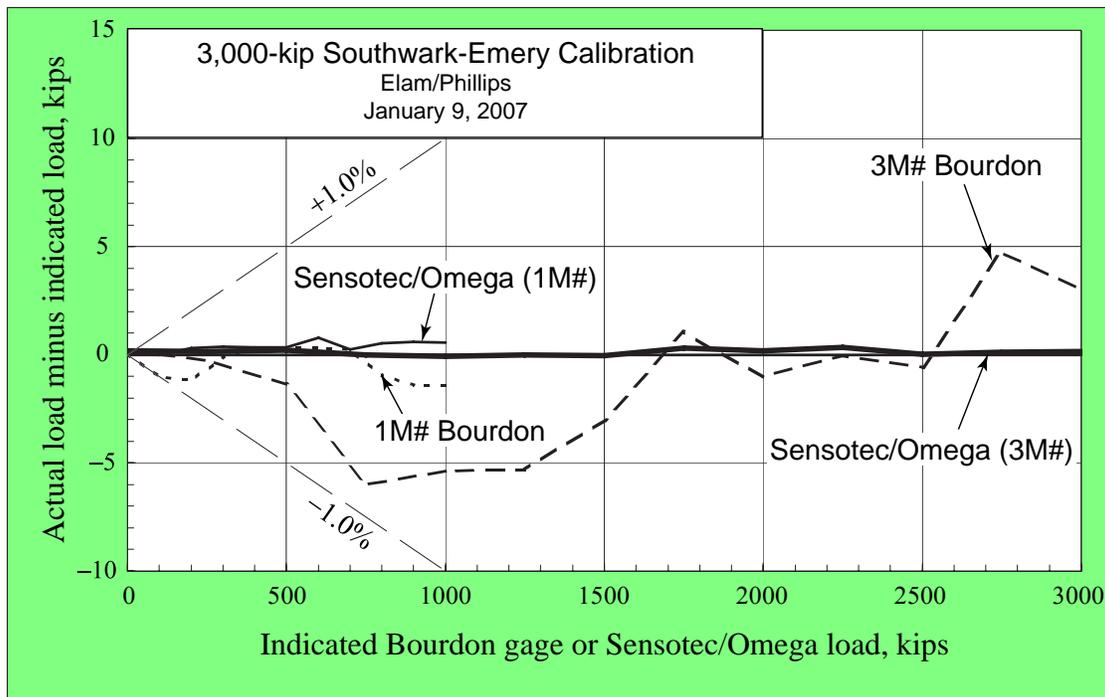
**Fig. 1. Plots of the deviation (actual load minus indicated load) as functions of the indicated load, for the 1,000,000-lb and 3,000,000-lb Bourdon gages and Sensotec transducer, after the January 9, 2007, calibration.**

It was found, in the 1983 calibration, that both the 1,000,000-lb gage and the 3,000,000-lb gage were extremely linear in their response to the load. Any nonlinearity in either gage’s response was masked by a seemingly reproducible deviation perhaps related to the pitch of the rack-and-pinion mechanism in
