FULL-SCALE CYCLIC EXPERIMENTS OF COMPOSITE MOMENT-RESISTING FRAME CONNECTIONS

**A Report from the National Earthquake Hazards Reduction Program
Northridge Earthquake Research Investigation**

Report No. ST 98-02
Department of Civil Engineering
University of Minnesota
Minneapolis, Minnesota 55455

March 1998

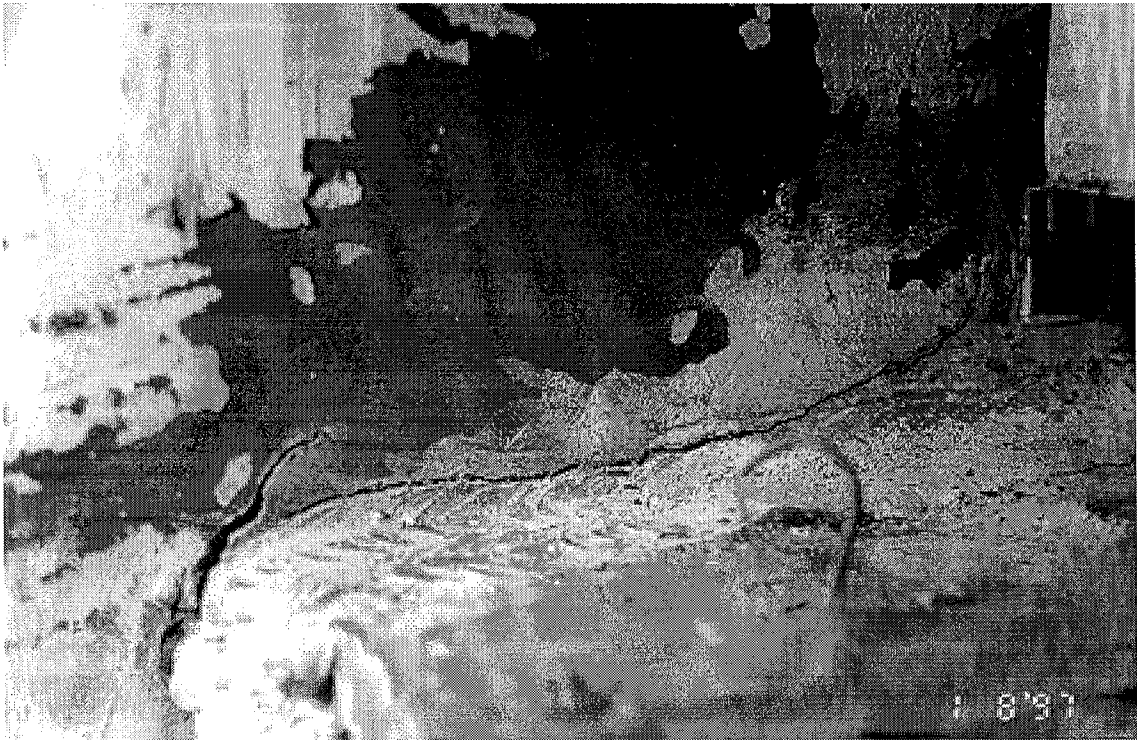
Figure 5.62: Pull Out-Type Failure of Column Flange (West Girder of Specimen 2)

These reductions in girder strength and ductility of the connections possessing bottom backup bars are a direct result of their premature fracturing during the 1.5% drift levels. The fractures occurred at the column flange-bottom CJP weld interface, near the location of the bottom backup bar. The fracture of the West connection of Specimen 2 was significant in that the fracturing of the bottom weld accompanied the fracturing of the West column flange (see Figure 5.62; Section 3.2).

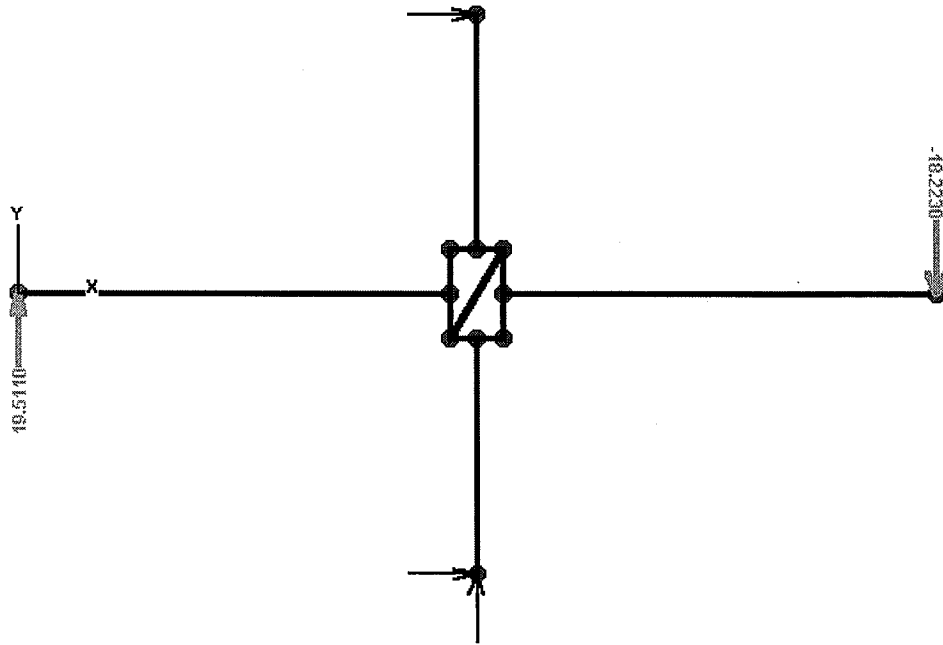
Figure F.8: Computational Model of Specimen 3/ 0.25% Drift Level
(Pinned Bottom Column Support/ Laterally Supported Top Column Support)

The girder and column flexural deformation equations (see Eqs. F.7, F.15, and F.25) are verified simultaneously, along with investigating the pinned column support and the fixed column support conditions separately. For the pinned column support condition, the girder tip deflection due to column and girder flexure (using Eqs. F.7 and F.15) is compared to the girder tip deflection that is determined using a computational model that assumed pinned column supports (the top and bottom supports were allowed to rotate). For the fixed column support condition, the girder tip deflection due to column and girder flexure (using Eqs. F.7 and F.25) is compared to the girder tip deflection that is determined using a computational model that assumed fixed column supports (the top and bottom supports were fixed against rotation). The computational model is monotonically loaded at the girder tips, with loads and girder, column, and panel zone stiffnesses as defined above. To represent the actual support conditions when
