Structural Engineering Report No. ST-99-1

**BEHAVIOR OF SHEAR CONNECTORS IN
STEEL FRAMES WITH REINFORCED
CONCRETE INFILL WALLS**

February 1999

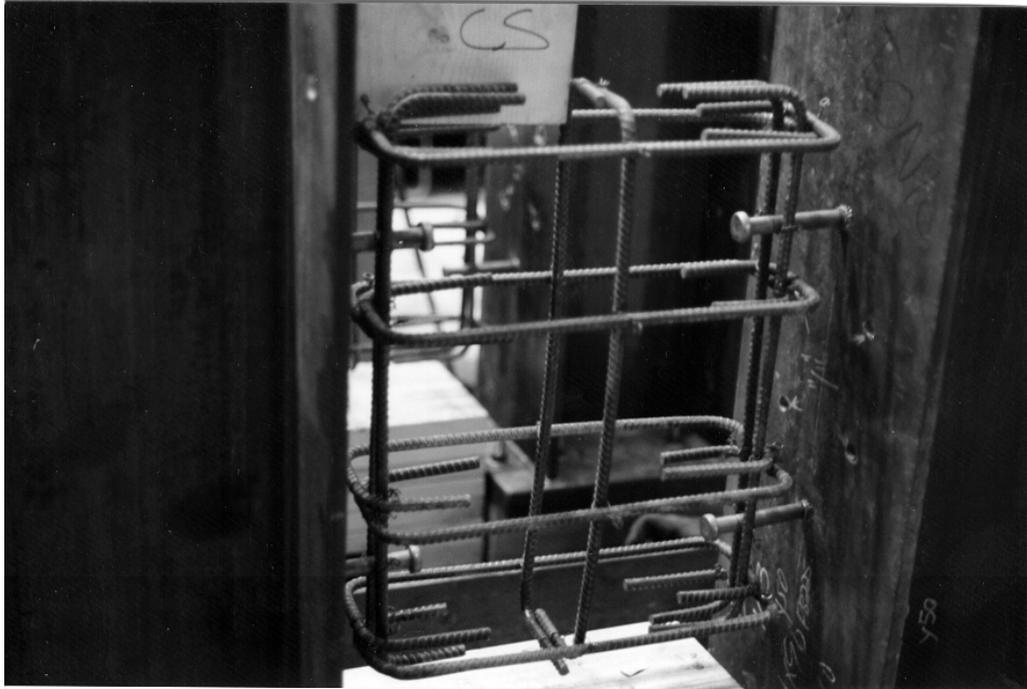
Figure 3.3 Photograph of the experimental test setup

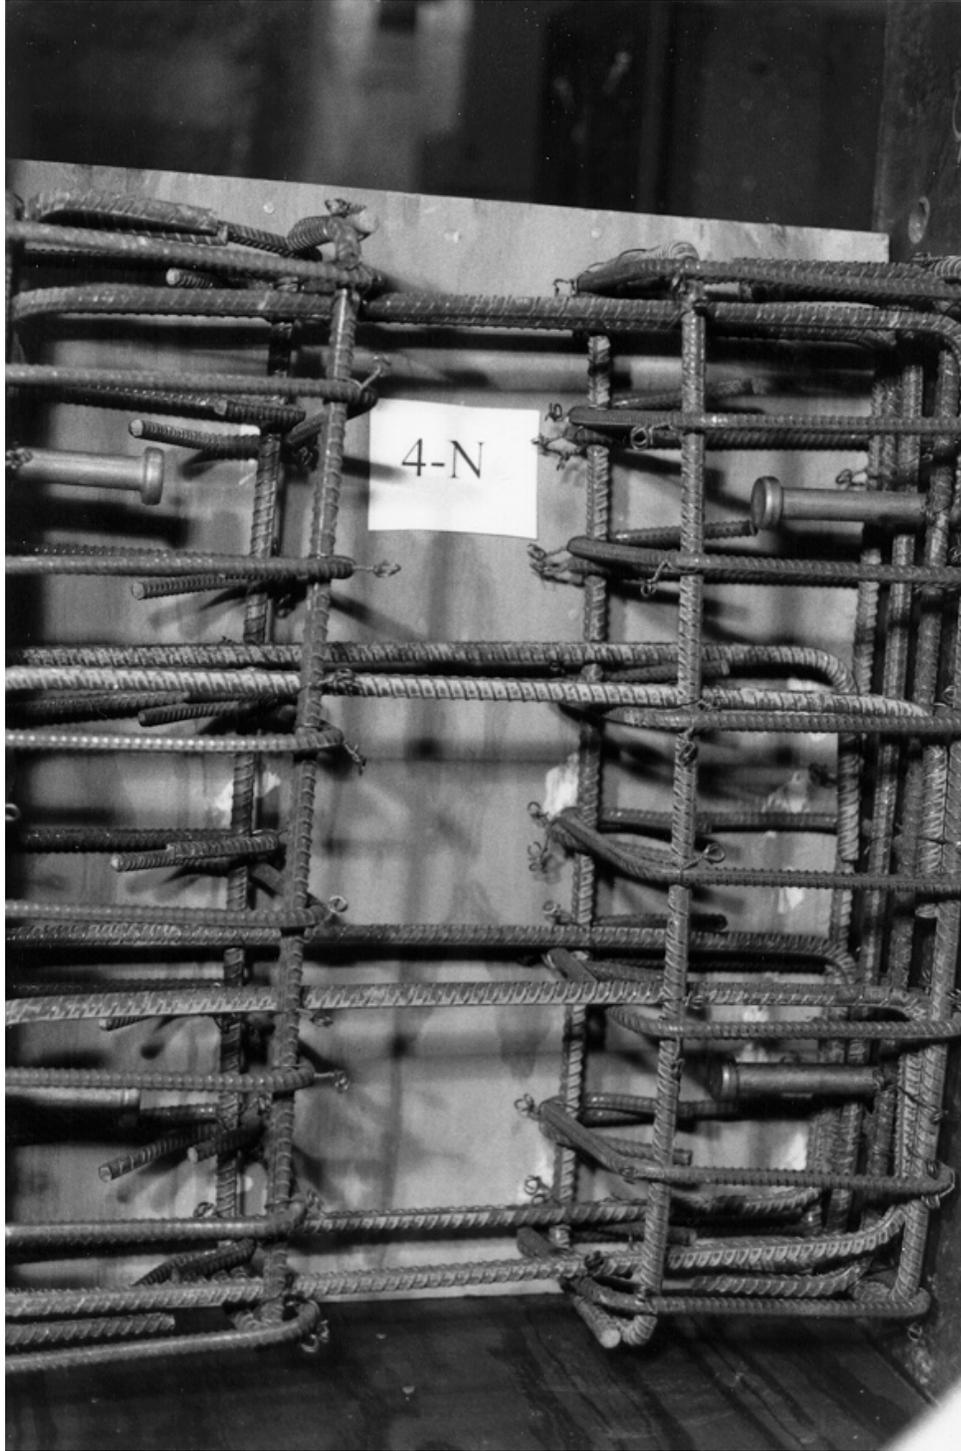
Figure 3.7 “Cage” steel reinforcement configuration

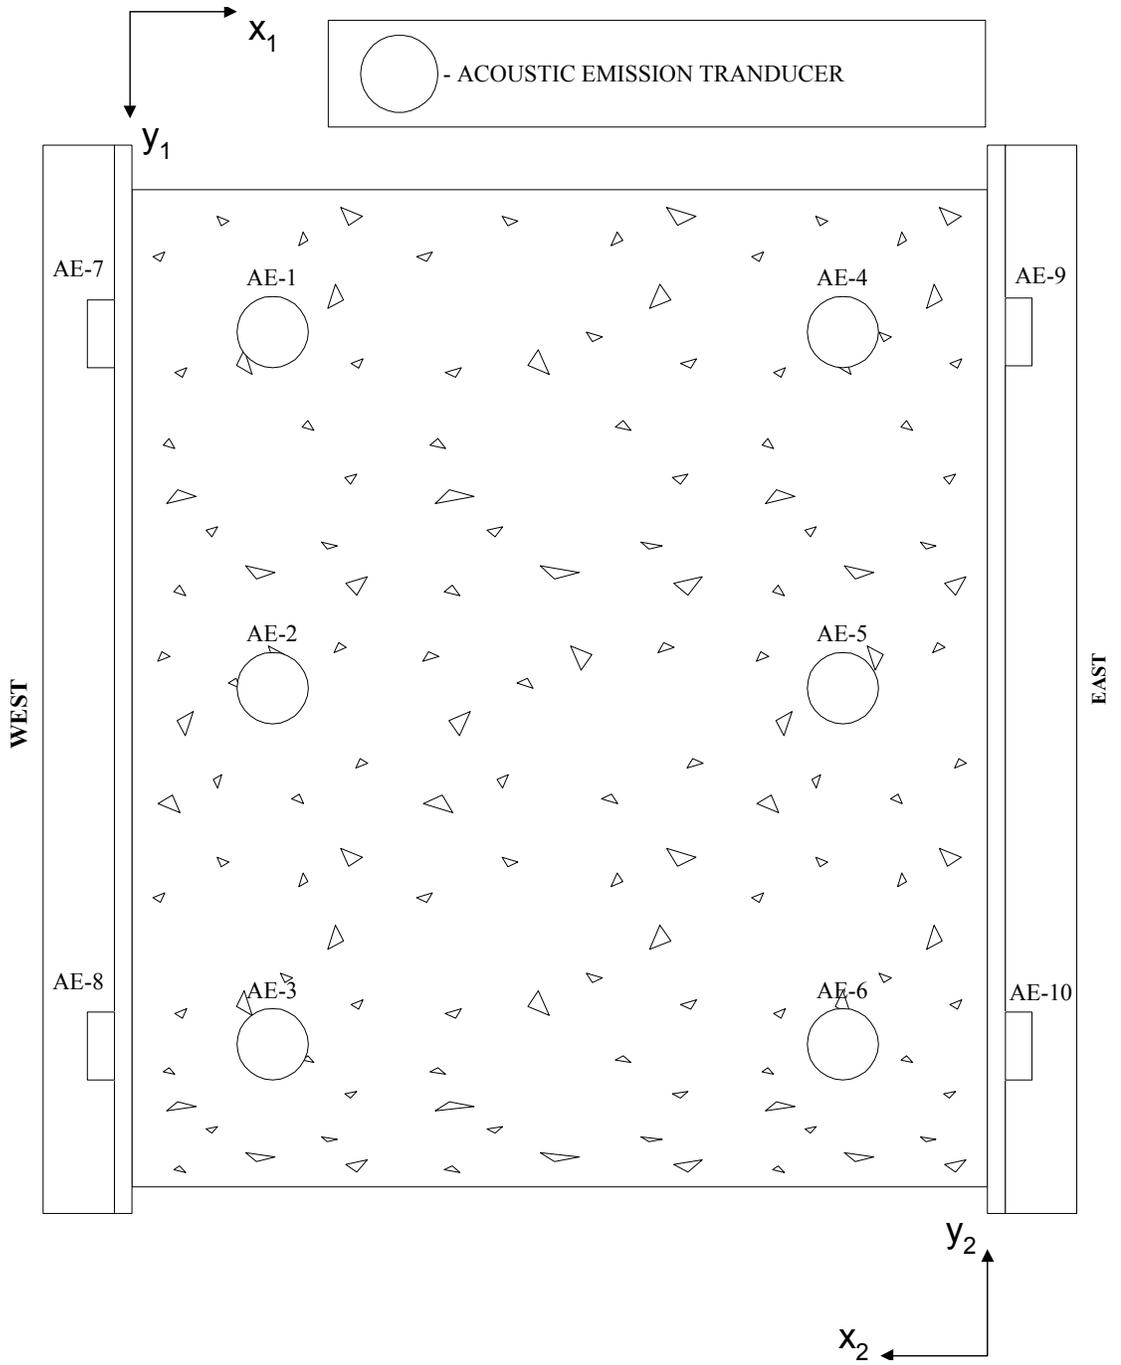
Figure 3.10 North face instrumentation

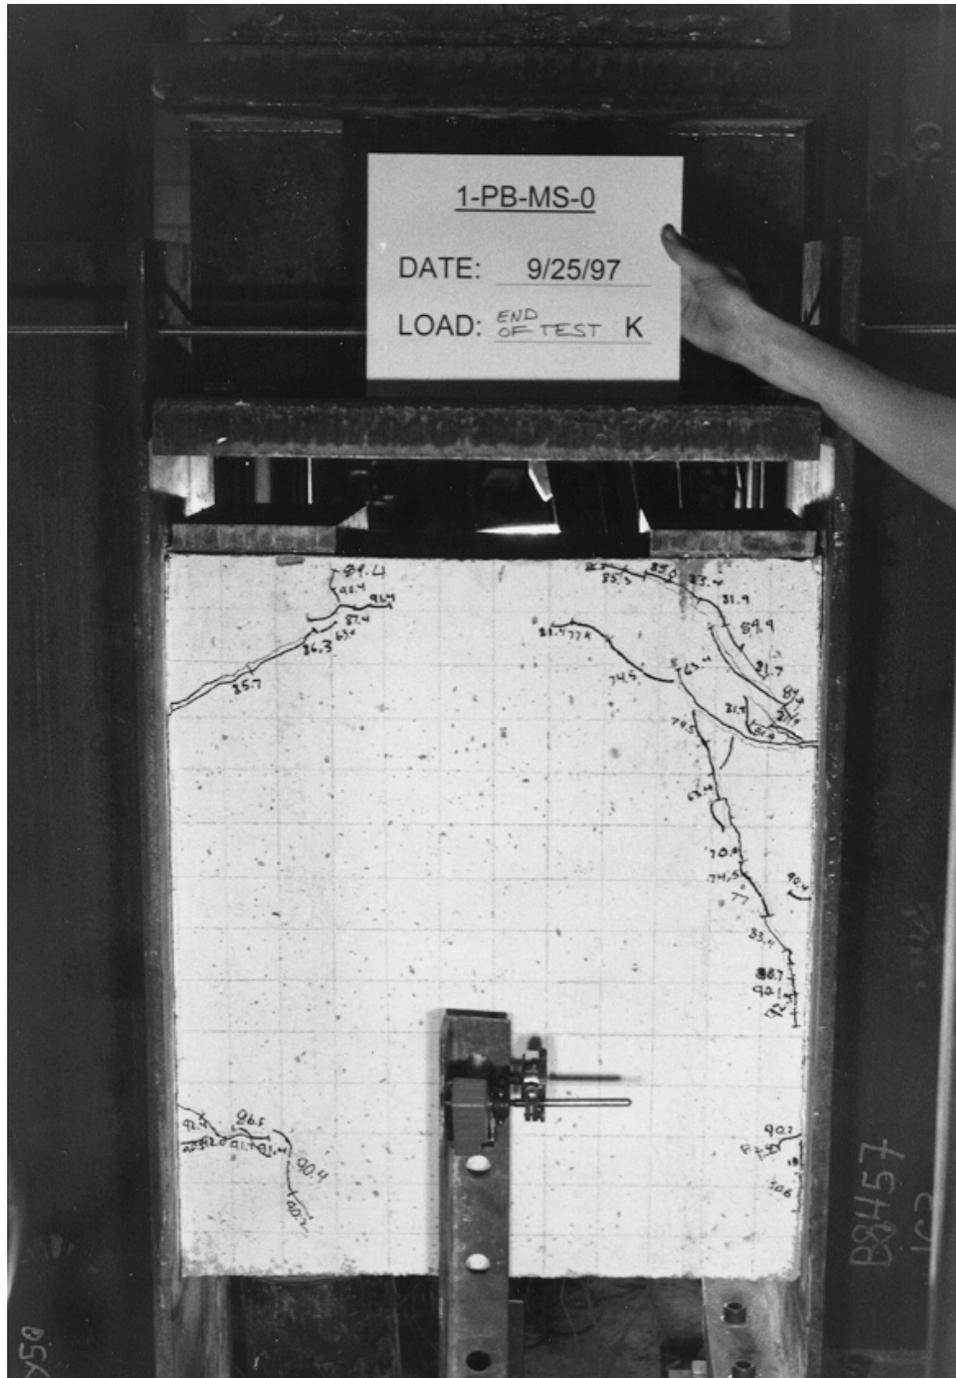
Figure 4.1 Crack Pattern for Specimen 1, north face

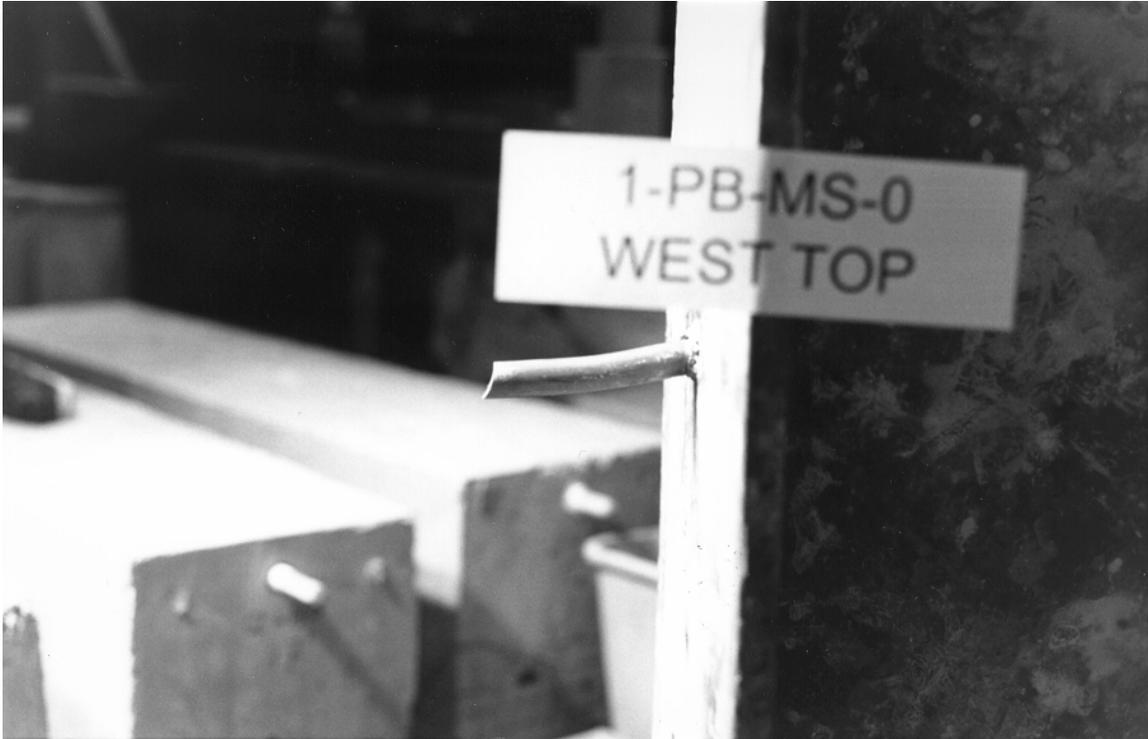
Figure 4.2 Photograph of Specimen 1, south face, after testing

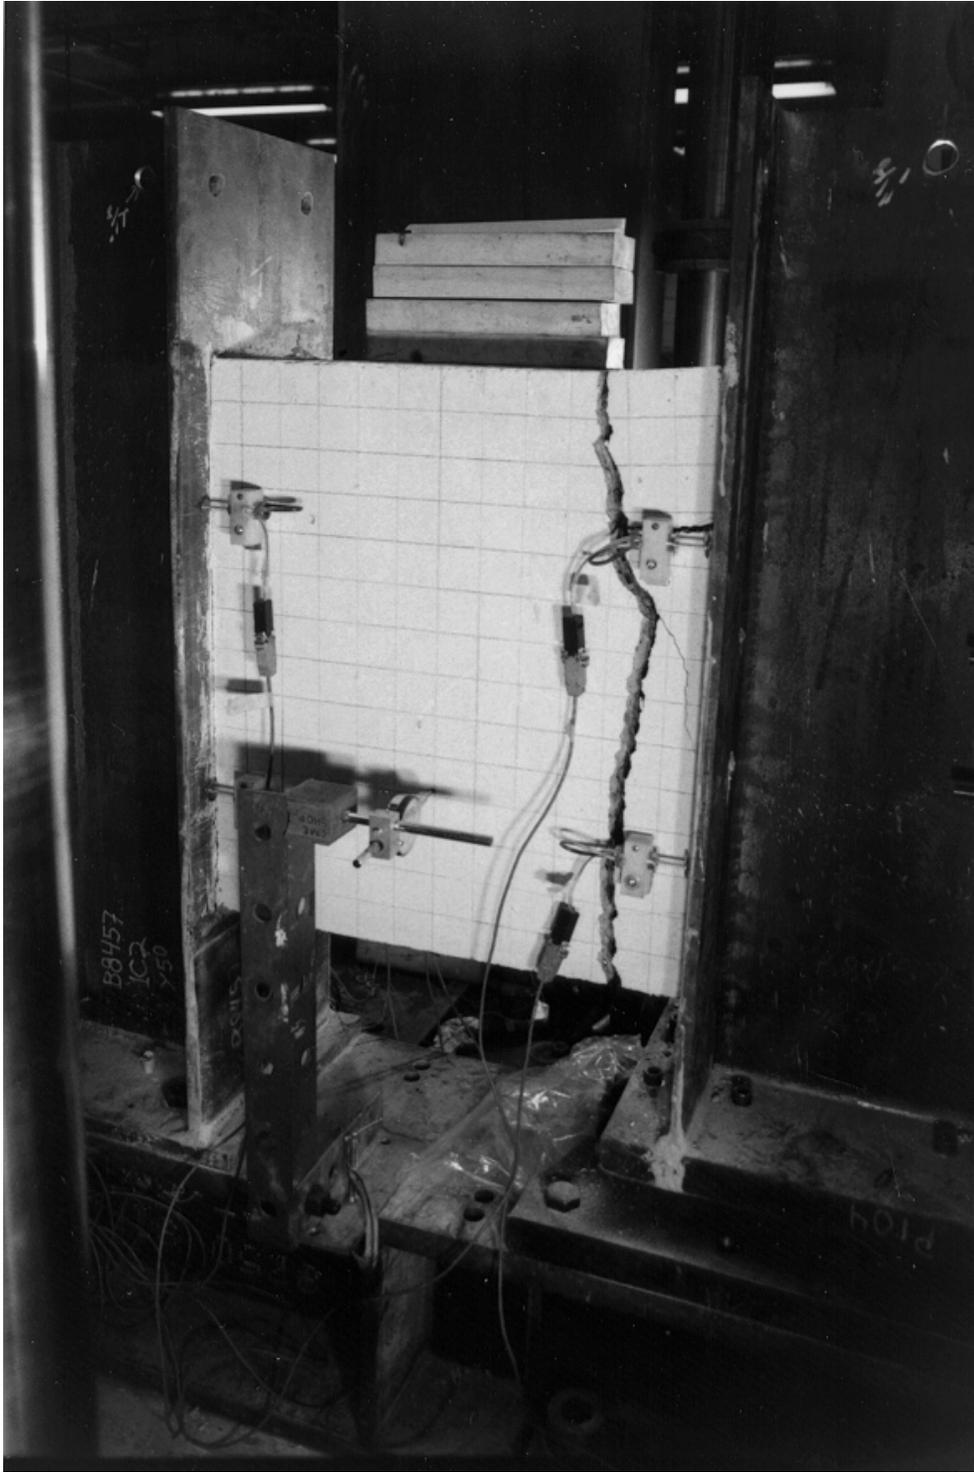
Figure 4.7 Crack pattern for Specimen 2, south face

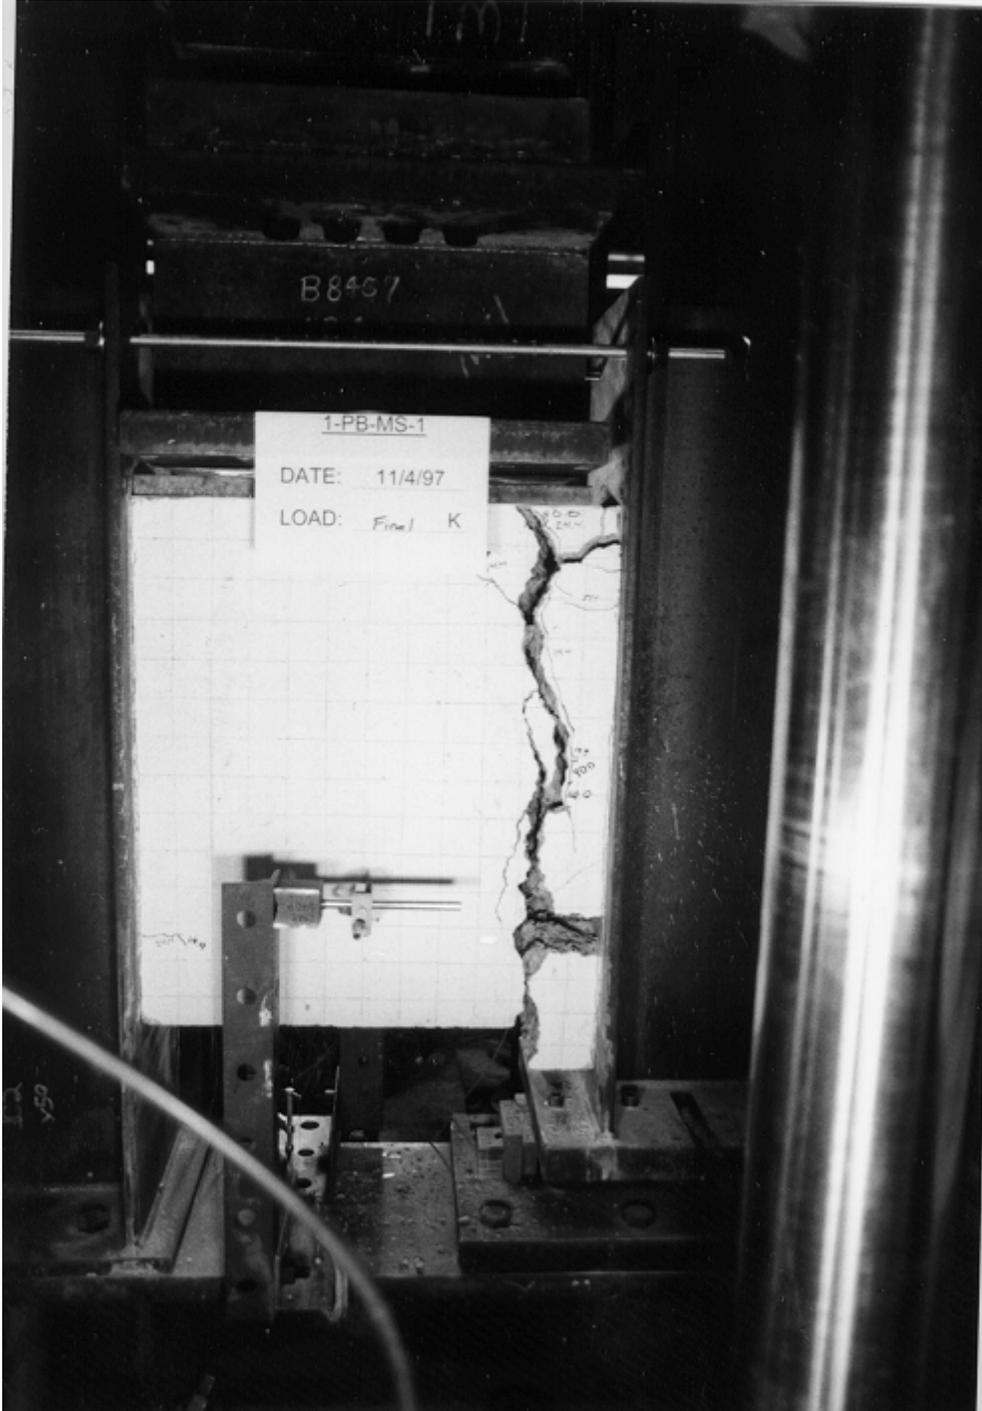
Figure 4.12 Crack pattern for Specimen 3, north face

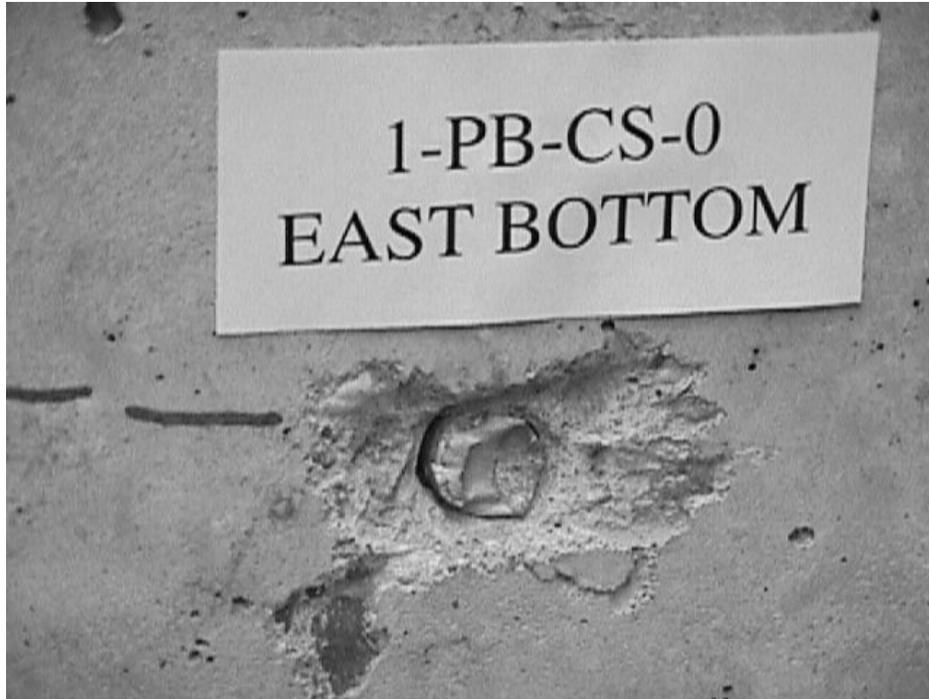
Figure 4.19 Photograph of stud failure surface for Specimen 4

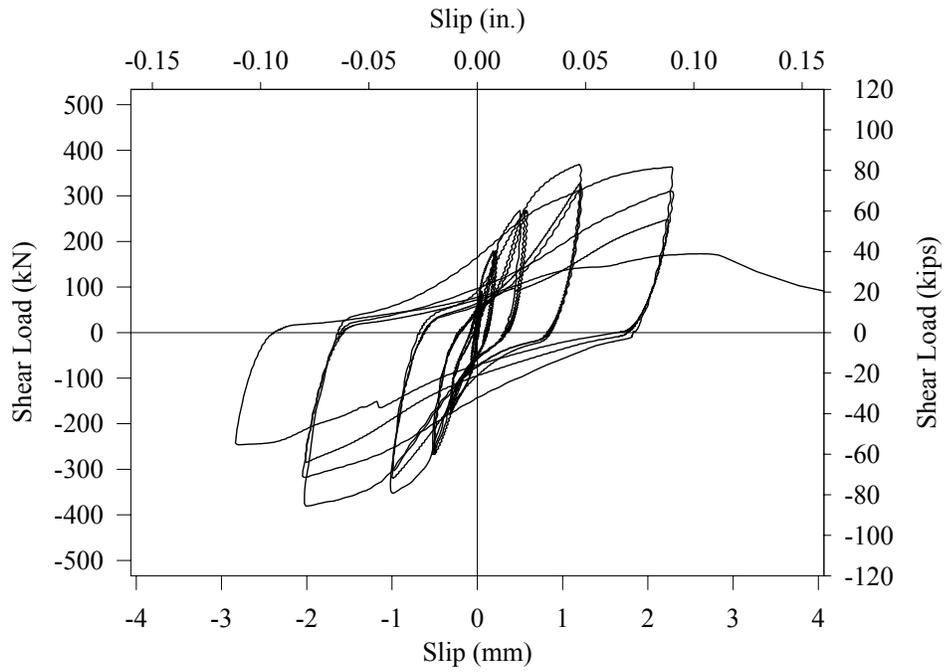
Figure 4.21 Load versus west slip for Specimen 4

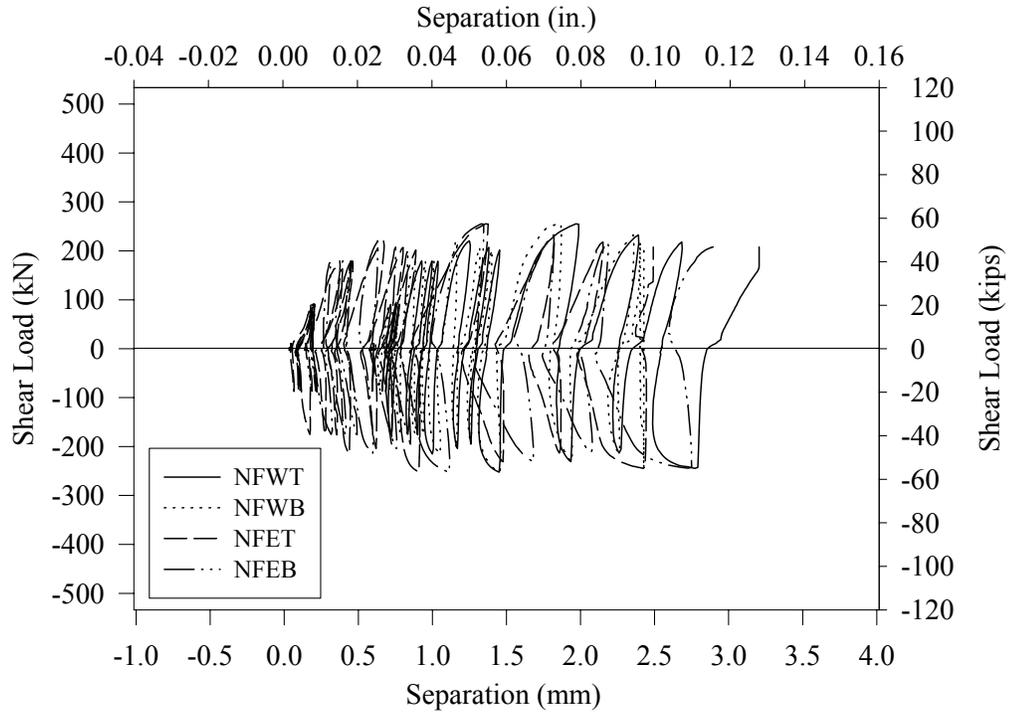
Figure 4.48 Load versus separation for south face LVDT's during shear loading for Specimen 8
