Recommended Improvements to the Southwest Corridor Path Intersections

Transportation Capstone Class of 2009 Advisors: Peter Furth & Dan Dulaski

January-February 2009

Attention:	Mr. Jeffrey Ferris
Cc:	Professor Daniel Dulaski and Professor Peter Furth
	Northeastern University
Subject:	Report on Recommended Improvements for Bicycle Path Intersections
	Southwest Corridor Park
	Boston, Massachusetts

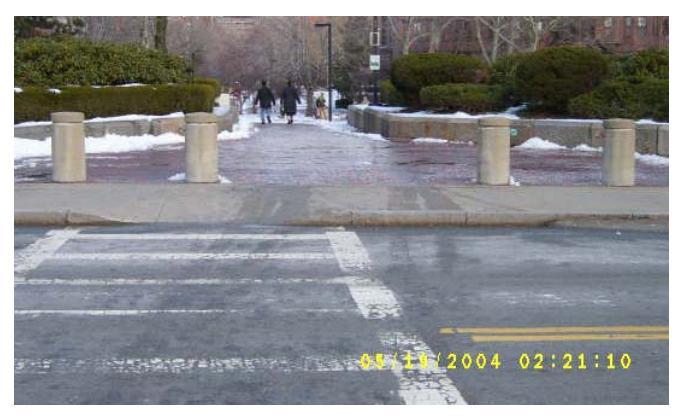
Southwest Corridor Looking Inbound

At the midblock crossing of the Southwest Corridor along W. Newton Street there are a few areas which may be hazardous to drivers, cyclists and pedestrians. Sight distance is a major issue for drivers on W. Newton St. and the poor alignment of the crosswalk crossing W. Newton St. with the ramps and bollards is a problem for pedestrians and bicyclists.

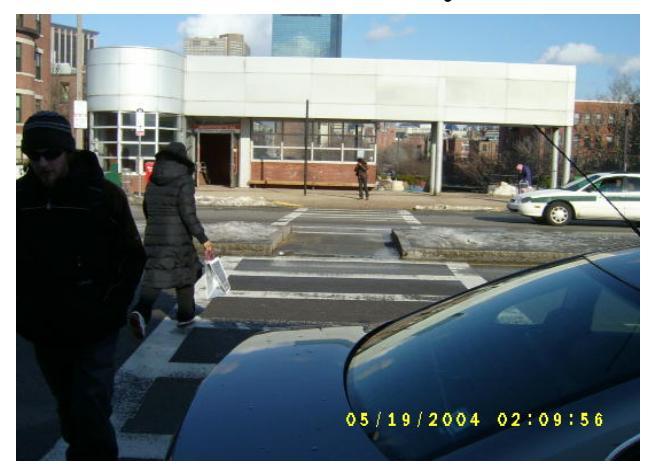
The intersection of the Southwest Corridor bicycle path and Massachusetts Avenue is a congested crossing carrying commuters to the MBTA, pedestrians, and cyclists. Mass. Ave is a four-lane collector road with high volumes of vehicle traffic. The main issue at this intersection is a lack of sight distance and effective advanced visual warning for motorists. The median on Mass Ave. eases crossing, but the curb cut in the median is not wide enough for both bikes and pedestrians to use. Most cyclists, including some on our own team, must hop the median during peak use.

Pedestrian Bottleneck in Median

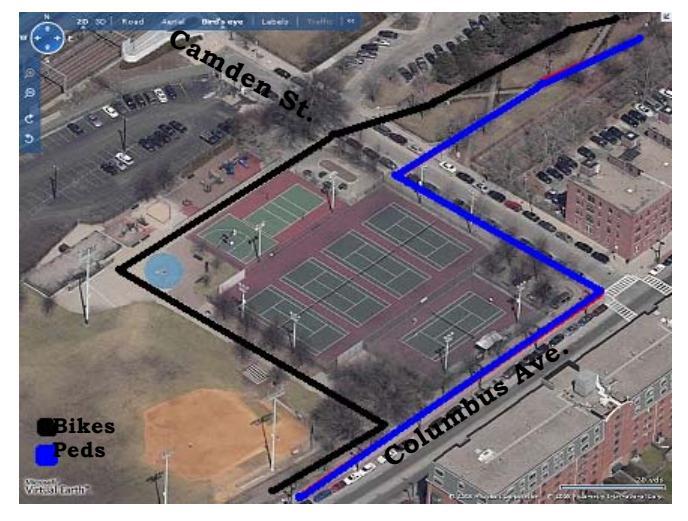
SW Corridor Path and WM E Carter Playground

- The redirection of the bicycle path on the Southwest corridor is very difficult to notice. This causes bicyclists to continue on the sidewalk and across Massachusetts Avenue, interfering with the high volume of pedestrians and vehicles.
- Vehicles traveling along Camden Street do not have any signage or crosswalks indicating that there is a path crossing.

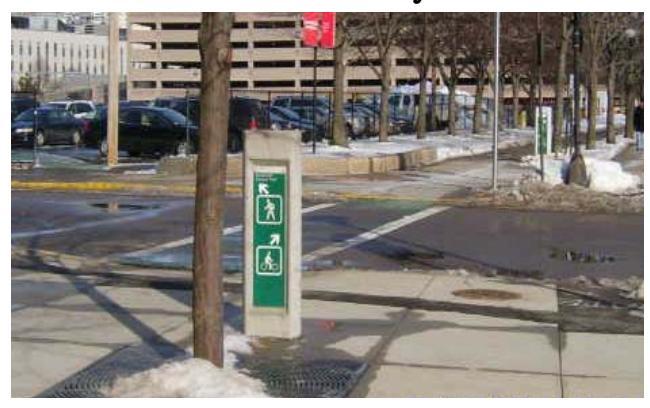
Southwest Corridor Looking Inbound-Bollard to be Modified

- Remove the path designation sign on the bollard facing users heading inbound and replace it with the proposed "Path Merge" (SP-1) sign.
- Place a sign on the backside of the same bollard (facing users heading outbound) that designates the bike and pedestrian paths.
- On the bollard on the North leg of the intersection, place a "Path Merge" (SP-1) sign on the backside; the side facing users heading outbound.
- Use standard treatment for navigation signs at this intersection.

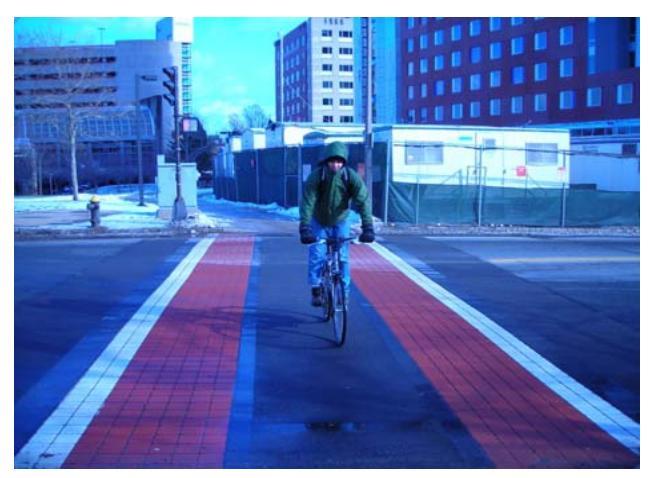
The intersection at Ruggles Street presents issues common to most of the crosswalk. The safety of the intersection is better than many others, as the SWCP has a stop light controlled by push button for two crosswalks. The crosswalk at the intersection was recently restriped and fitted with stone inlays, but could still be further improved to coordinate with the widening of the wheelchair ramps. The crosswalks also have some visibility issues as the crossing is on the top of a hill.

Cyclist in New Crosswalk

• The standard wheelchair ramp widening will be applied here as the ramps are currently only 48 inches, However this cannot be completed on one side until construction fencing is removed.

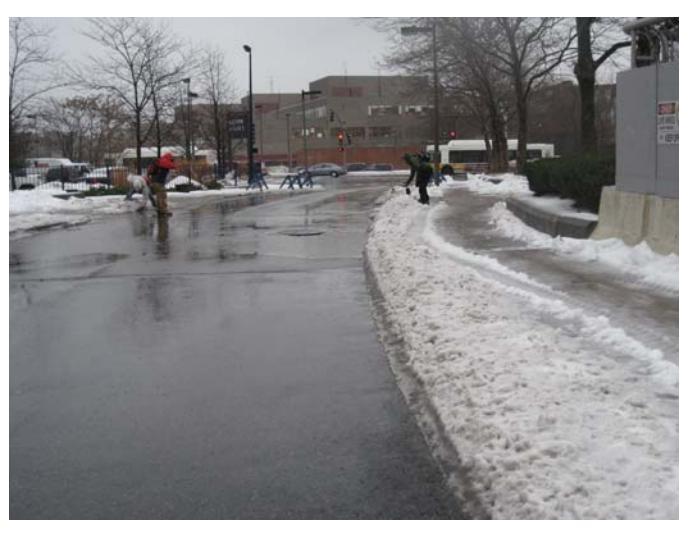
Southwest Corridor at Prentiss St

Blocked Sightline Due to Paneling

- Install vield signs for bicyclists to address sight line deficiencies on Prentiss Street SB approach due to railway paneling on bridge.

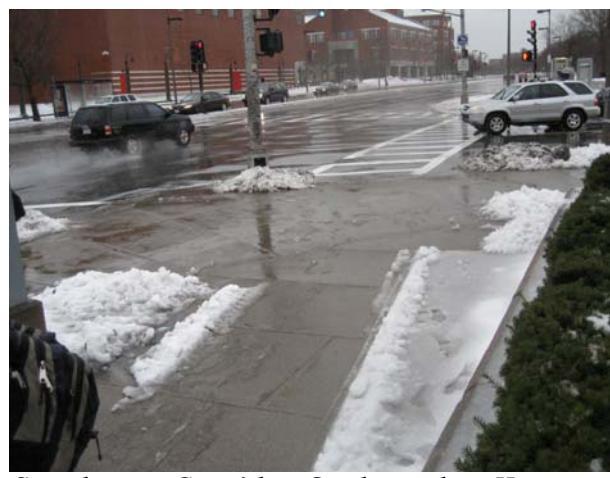
At the crossing of the Southwest Corridor and Tremont Street at Roxbury Crossing there is a lack of driver awareness of the crossing pedestrians and cyclists. The crossing is relatively safe due to it being signalized with an exclusive pedestrian phase however some small changes can be made to enhance the safety of this intersection

Southwest Corridor Outbound — Note vehicle in upper left that is stopped in the crosswalk

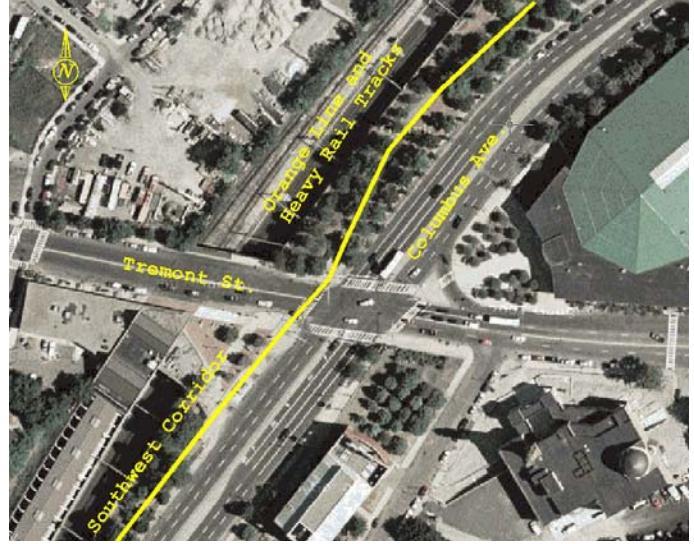
- Inbound directional bollard blocked by signal control box.
- Lack of signage indicating bicycle path crossing.
- Pavement/Path Markings
 - Stop bar is too close to the crosswalk resulting in vehicles blocking bicycles.
 - Crosswalk is in good condition and of acceptable width.

Inbound—Blocked Directional Bollard at Tremont Street

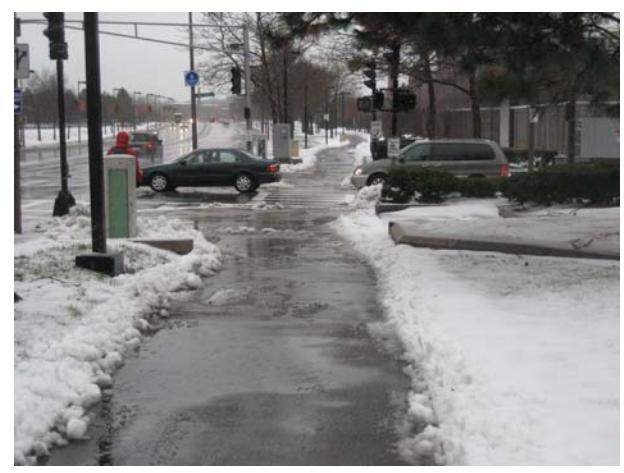
Southwest Corridor Outbound

At the signalized crossing of the Southwest Corridor and New Cedar Street poor maintenance has led to faded signs and crosswalks, resulting in low vehicular awareness of the bicycle intersection. The intersection is relatively safe due to the low traffic volumes and signal but small improvements can be made to enhance the safety of this intersection as well as making it more comfortable for users.

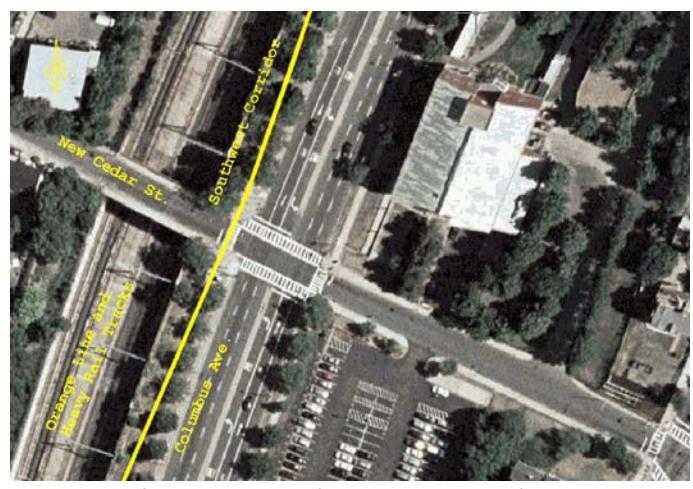
Outbound— Blocked Directional **Bollard at New Cedar Street**

- Move bollard in front of control box.
- Replace bicycle/pedestrian path crossing sign at vehicle approaches and put at appropriate height.
- Replace faded signs.
- Re-align 'Stop Here On Red' sign with stop line.
- Add signage on path warning of path merge.
- Promotional signage along vehicle approach alerting bicyclists of path and distances to destinations.
- Add NTOR sign on New Cedar Street so drivers will not stop in crosswalk.
- Crosswalk
 - Repaint ladder style crosswalk 10' wide.
 - Move crosswalk on Columbus back to allow for new ramp.

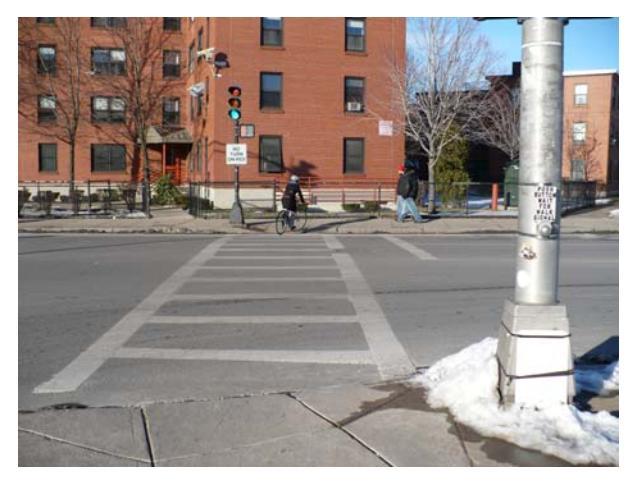
- Bicyclists crossing Centre St. face a conflict with pedestrians on the north side leg due to tight a right angle turn onto and off of an already narrow sidewalk.
- SWCP approaches on either side of Centre St. are offset and angled differently, eliminating a smooth transition for path users.
- No signage exists to distinguish the right of way for all intersection users.
- Handicap ramps not adequate width for shared use of bicyclists and pedestrians.

Bicyclist Crossing Centre St. From Lamartine St. w/ Conflicting Pedestrians

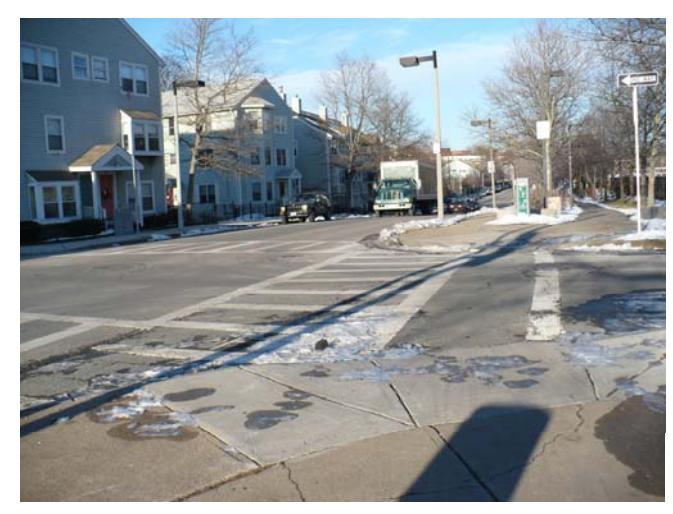
Inbound Approach Crossing Atherton St. Along Lamartine St.

At the crossing of Atherton St. along Lamartine Street the main issue is that the crosswalk and stopline are offset from the curb cuts. This creates an inconvenient crossing for pedestrians and bicyclists.

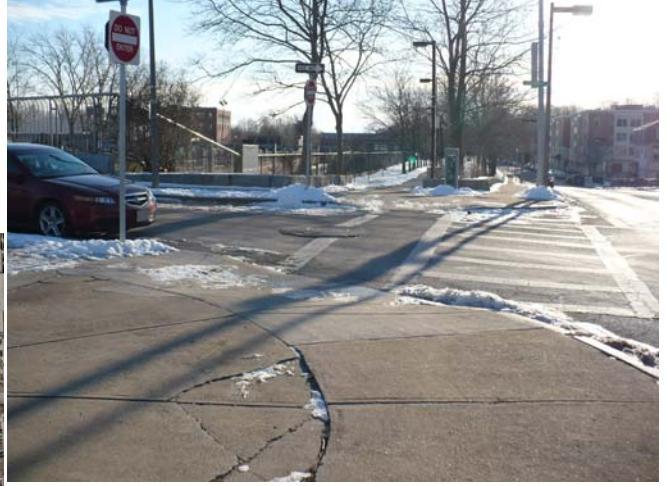
Outbound Approach Crossing Atherton St.

- Crosswalk / Stopline
 - Offset from existing curb cuts on north and south sides of intersection.
 - Raised structure in street causing possible danger to bicyclists.
 - Curb cut widths inadequate for shared path users and multi-directional crossing
- Signage
 - Guidance bollards in good condition
 - No warning signs for vehicular traffic exist to let drivers know of trail crossing.

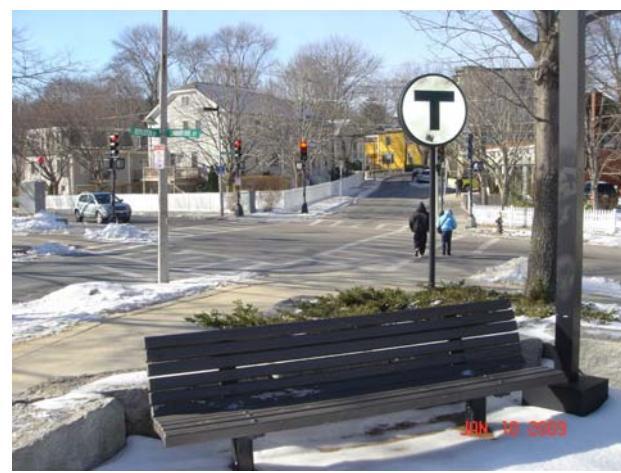
From Boylston St. Looking West Across Intersection

At the crossing of Boylston St. and Lamartine St., the main issue of concern is the lack of pedestrian compliance due to ped phases being actuated and not concurrent.

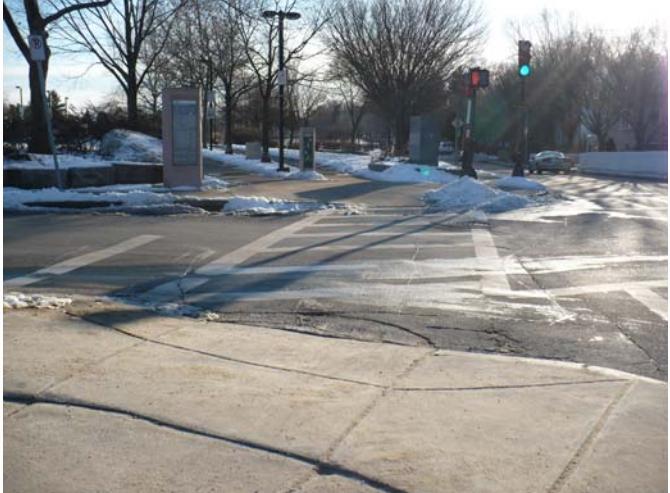
Outbound Approach Crossing Boylston Street

- Curb cuts are of inadequate width.
- Sidewalks provide ample queuing area for both pedestrians and bicyclists.
- Crosswalk in decent condition but of insufficient width.

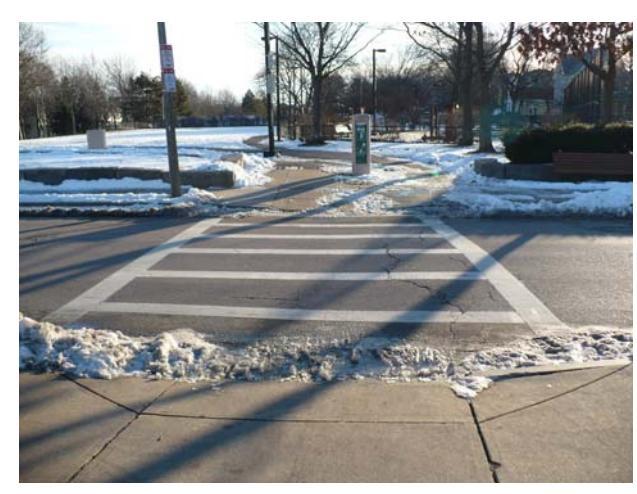
Outbound Approach Crossing New Minton Street

At the midblock crossing of the Southwest Corridor and New Minton Street, the main concern is the right of way designation for crossers. Current conditions provide no right of way guidance and little warning for all approaches. Other matters include adding signage consistent throughout the SWCP and addressing minor maintenance issues.

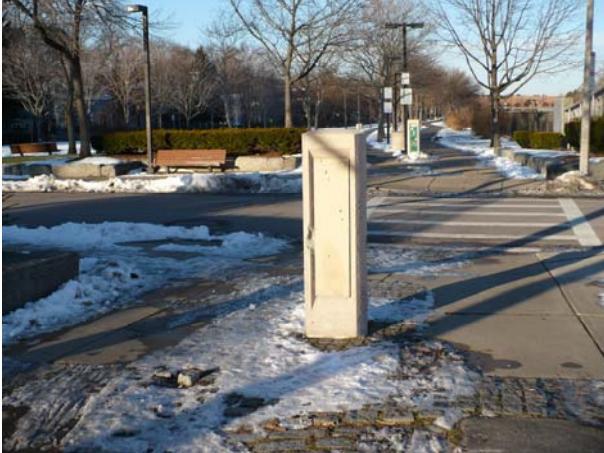
Inbound Approach Crossing New Minton

- Geometry
 - Existing curb cuts are too narrow to accommodate passing bicyclists.
- Other Findings
 - Cobble inlay meant to warn bicyclists of intersection is ineffective and uncomfortable for bicyclists.

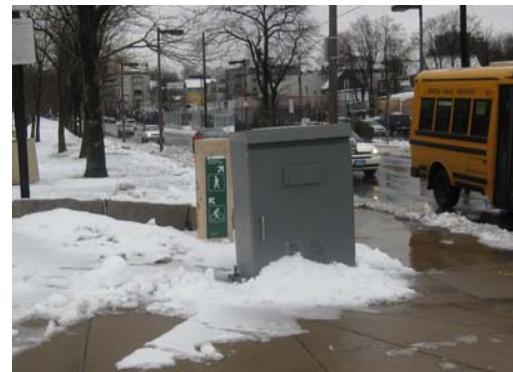
Sign Blocked by Traffic Controller

- Roadway Signage
 - There is not signage on the Green St, Gordon St., and Amory St. approaches warning vehicle there is a path crossing.
- Path Signage
 - The bollard on the north side leg of the path is blocked by a traffic controller box. This may create confusion for the path users as to which path they should be using. (see below)
- **Pavement Markings**
 - Due to the lack of maintenance the stop line for vehicles heading East on Green Street has been worn away. (see below)
- Curb Cuts
 - The crosswalk across Gordon St. does not line up with the existing handicap ramps. There is also a catch basin in the middle of the crosswalk on both sides of Gordon St.

- Roadway Signage
 - Signage should be added at all approaches indicating there is a path crossing ahead.
- Path Signage
 - The bollard on the north side leg should be moved next to the traffic controller.
 - A new guide sign should be installed.
- Pavement Markings
 - A Stop line should be added on the west side leg of Green Street.
 - A middle divider should be added on the bike path.
 - A bike legend should be added at the beginning of the divided path on both sides of the T station.
- Curb Cuts
 - The curb cuts on the Gordon St crosswalk should be relocated to the center of the crosswalk. Also the catch basins should be relocated as indicated on Figure 14.

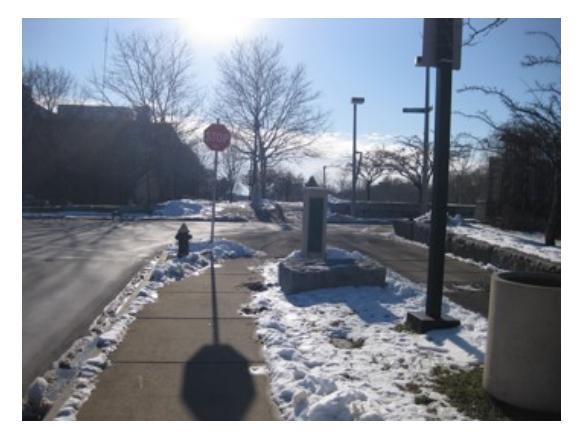
SWCP Outbound

- There is no signage for drivers on the Williams St. or Amory St. approaches warning drivers of the path crossing.
- Bollard is missing the path directional signage on the inbound and outbound sides.
- There is little indication of merging pedestrian and bike paths.

- Path surfaces are cracked and heaved throughout and the path on the south side has an extremely steep slope.

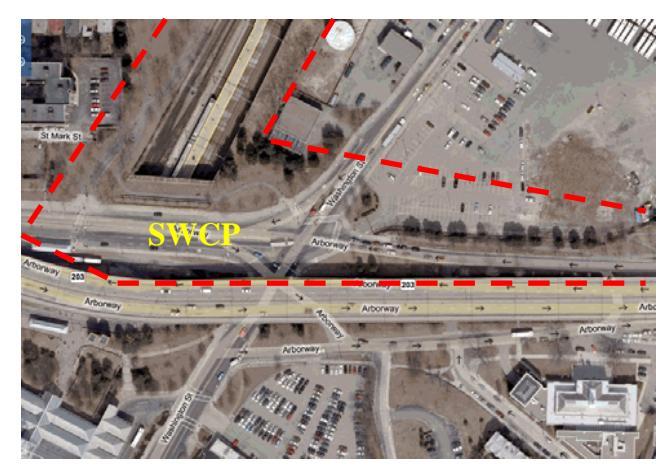
Washington St at New Washington St

The intersection of Washington Street and New Washington Street with the Southwest Corridor is located northeast of the Forest Hills station and east of the end of the bike path. Although it is used mostly by motorist on the busy Washington Street thoroughfare, in its current condition, it proves dangerous for crossings heading towards Franklin Park due to its complexity.

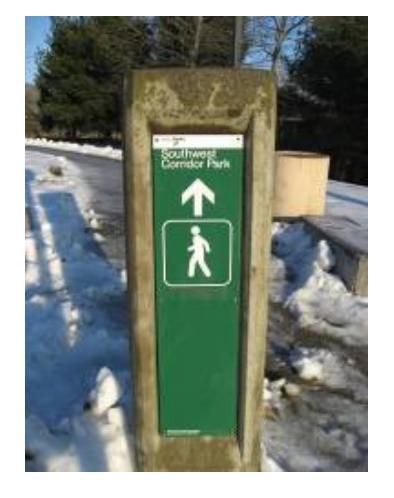
Pedestrian Only Path Designation

- Path Designation
 - The path from the MBTA Orange line tracks east is currently marked as a pedestrian only path.
- Signage
 - There is no signage at the intersection indicating that there is a crossing or any directional signs leading path users to destination points.
- Pavement Markings
 - Pavement markings are worn in and around the general area of the intersection.
 - The crosswalks are arranged in such a way that requires multiple crossings to continue on the path.
